Fire Resilience in Steel-Concrete Structures Part II: Advanced Solutions

Course No: S03-033
Credit: 3 PDH

This course was adapted from the NIST U.S. Department of Commerce, Publication No. NIST TN 2203, “Fire Resilience of a Steel-Concrete Composite Floor System: Full-Scale Experimental Evaluation for Influence of Slab Reinforcement (Test #2)”, which is in the public domain.

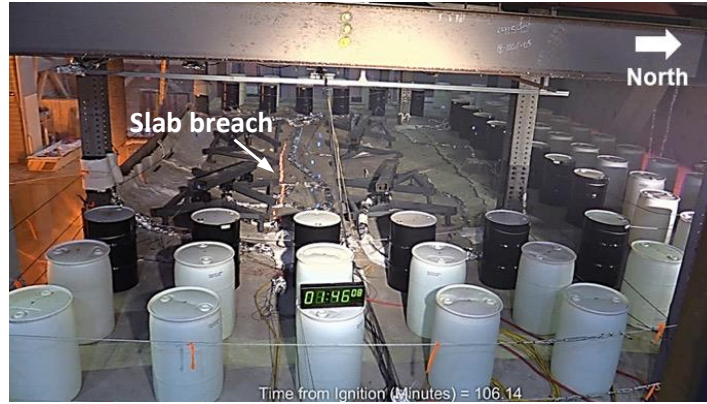
Whereas temperatures of the protected steel beams were acceptable compared to the ASTM E119 [13] limiting temperatures, significant integrity failure (concrete cracks) occurred in the heated composite floor before attaining the specified fire rating period. Large concrete cracks appeared around the hogging moment region (next to the test-bay column gridline) less than 30 min into heating, and the mid-panel concrete cracks began to occur at 70 min, exposing the hot glowing steel deck beneath along the longitudinal centerline (Fig. 2).

The limited ductility of the heated composite slab was the primary cause of the integrity failure which might initiate fire spread above the compartment of fire origin and eventually lead to local collapse mechanisms during longer (uncontrolled) fires. The steel wire reinforcement (60 mm²/m) embedded in the test floor slab ruptured in tension at critical locations as the thermally degraded composite floor sagged but before reaching the ASTM E119 displacement limit. The minimum steel reinforcement (60 mm²/m) prescribed for concrete crack control in normal conditions and permitted in standard furnace testing may not be sufficient to maintain the integrity of a full-scale composite floor undergoing the 2-hour standard fire exposure.

Fig. 2. Still image showing top of the Test #1 composite floor developing slab breach at 106 min after burner ignition.

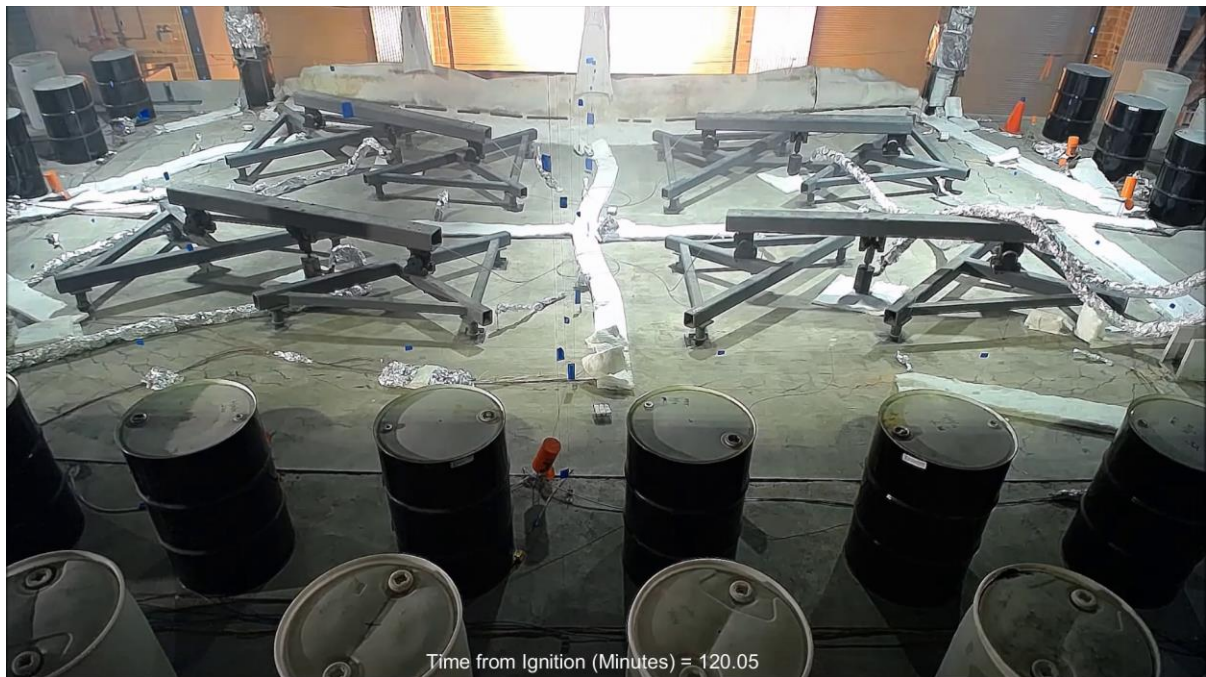
Fig. 29. Video image showing top of the test floor at 120 min after fire ignition.

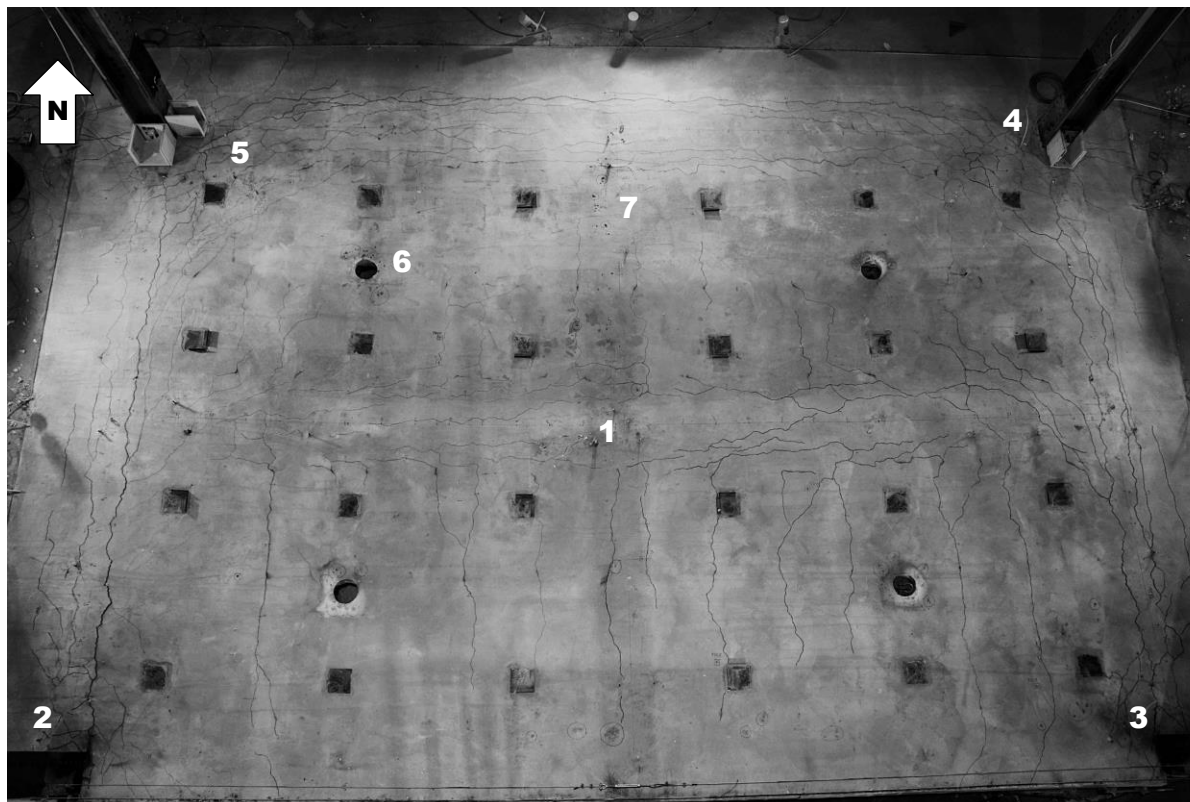
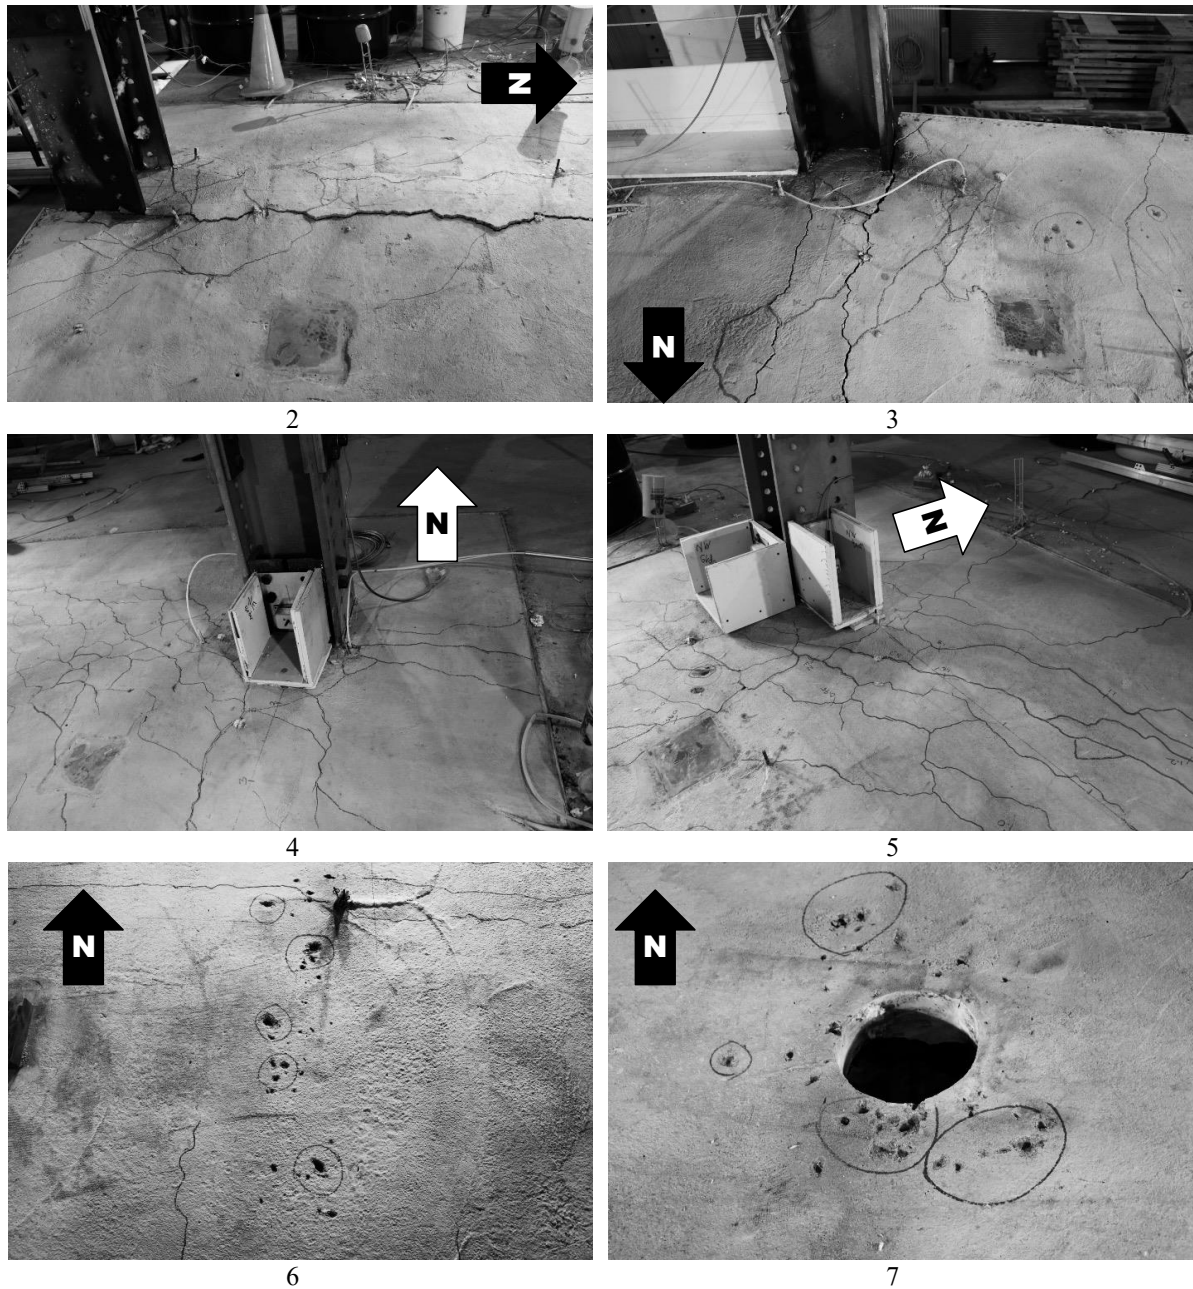
Fig. 35. Post-test photographs of the test floor slab, including closeups of concrete damage at locations 2 through 7.

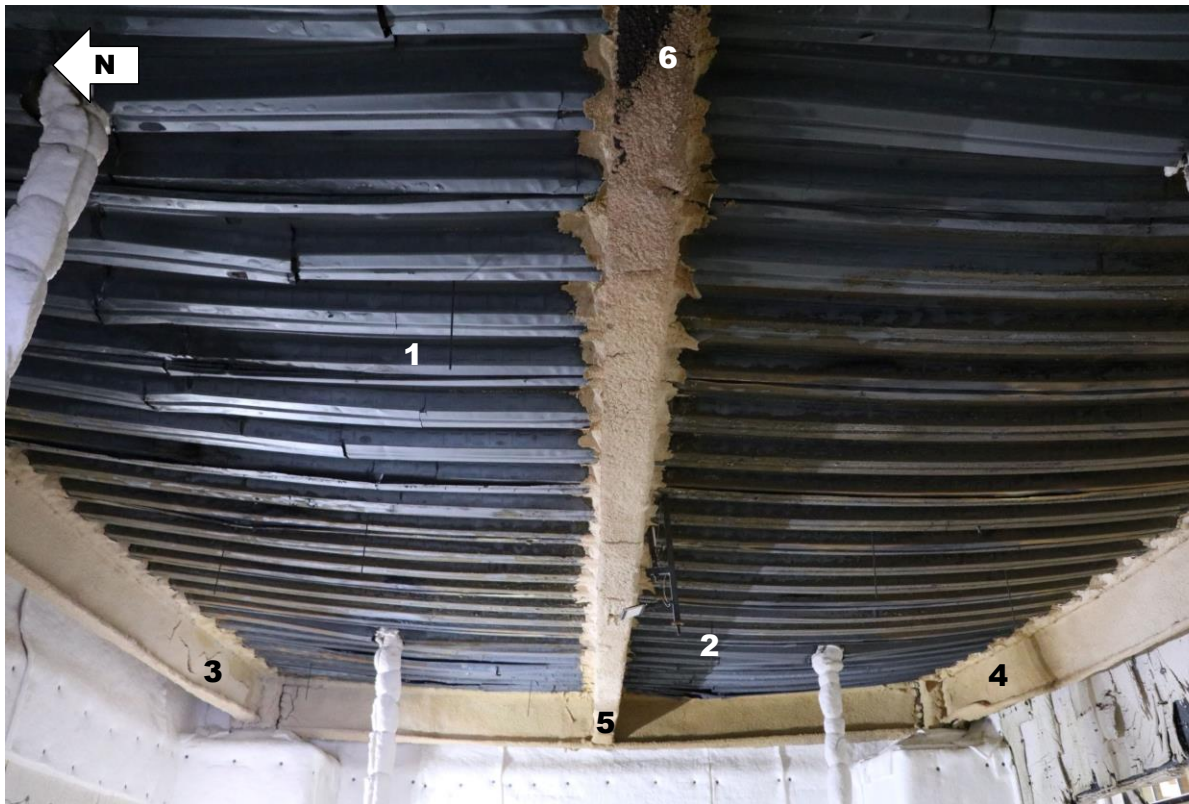
Fig. 36. Post-test photograph of the floor specimen soffit.

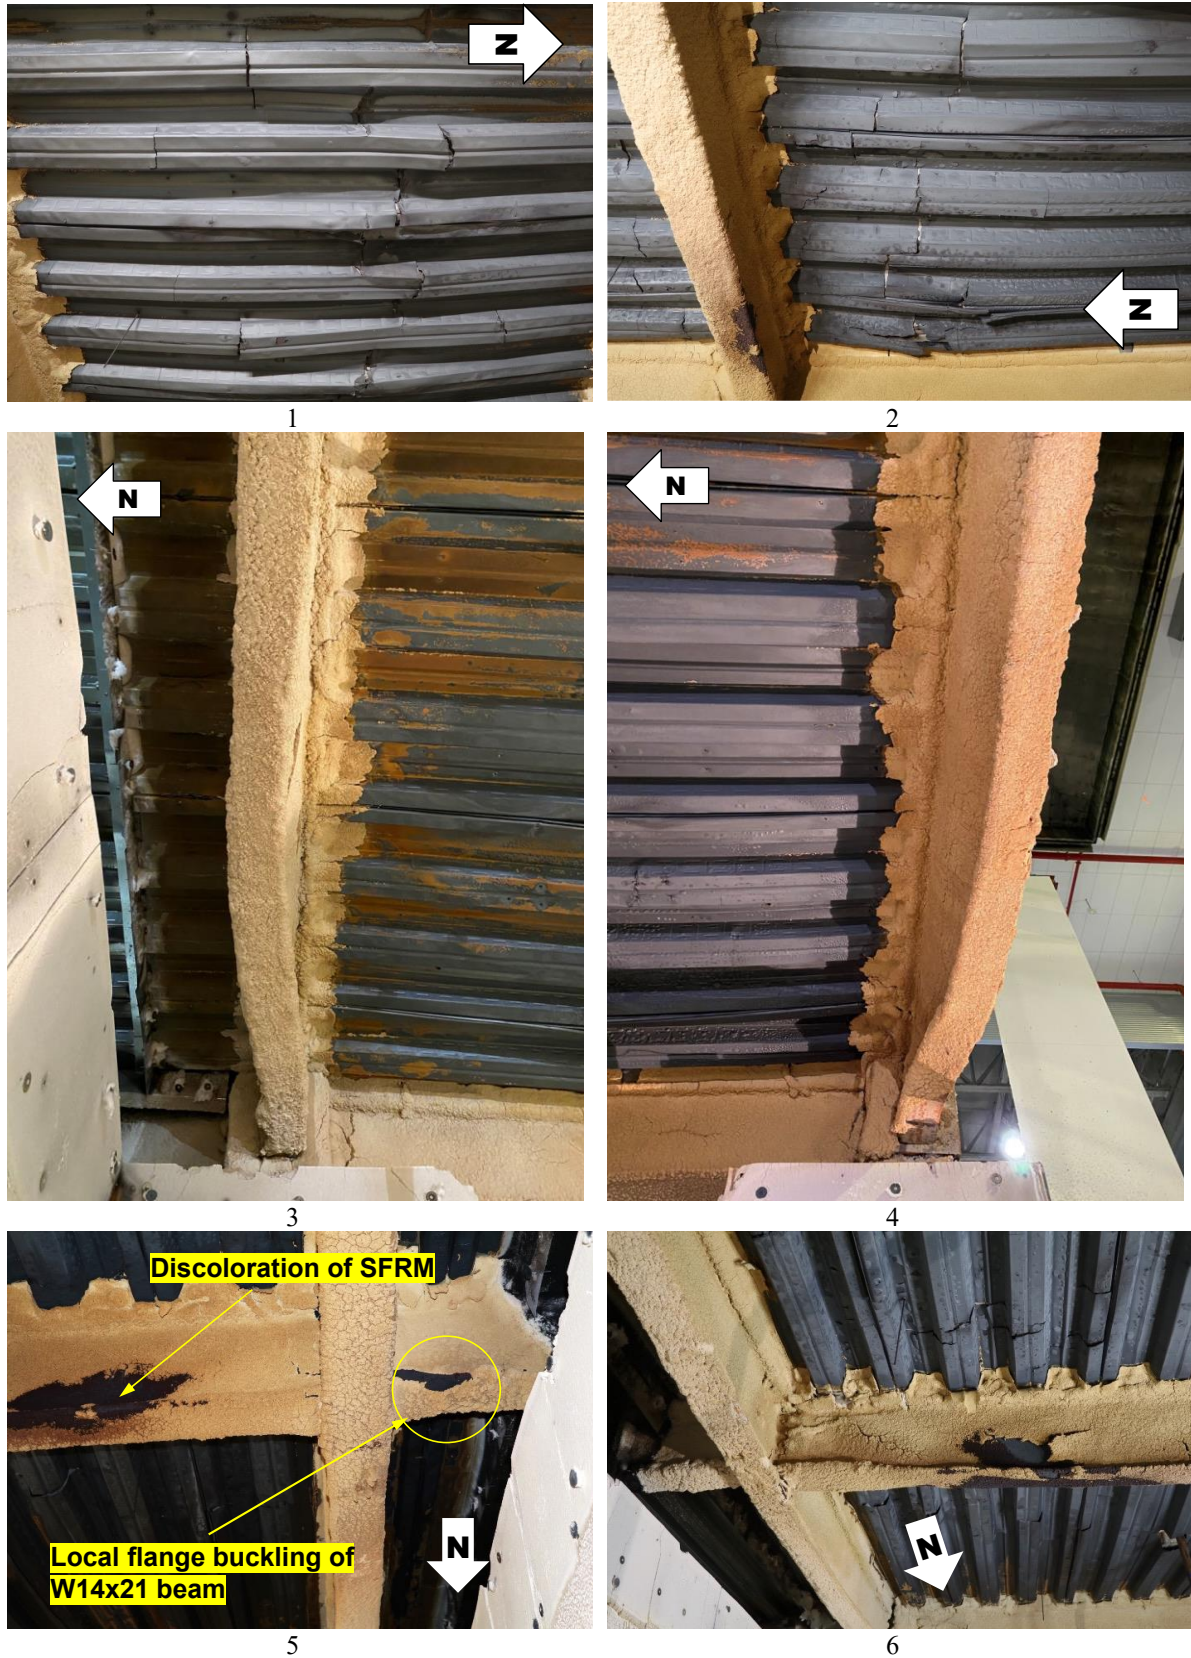
Fig. 37. Closeup photographs of steel damage at locations 1 through 6 shown in Fig. 36.

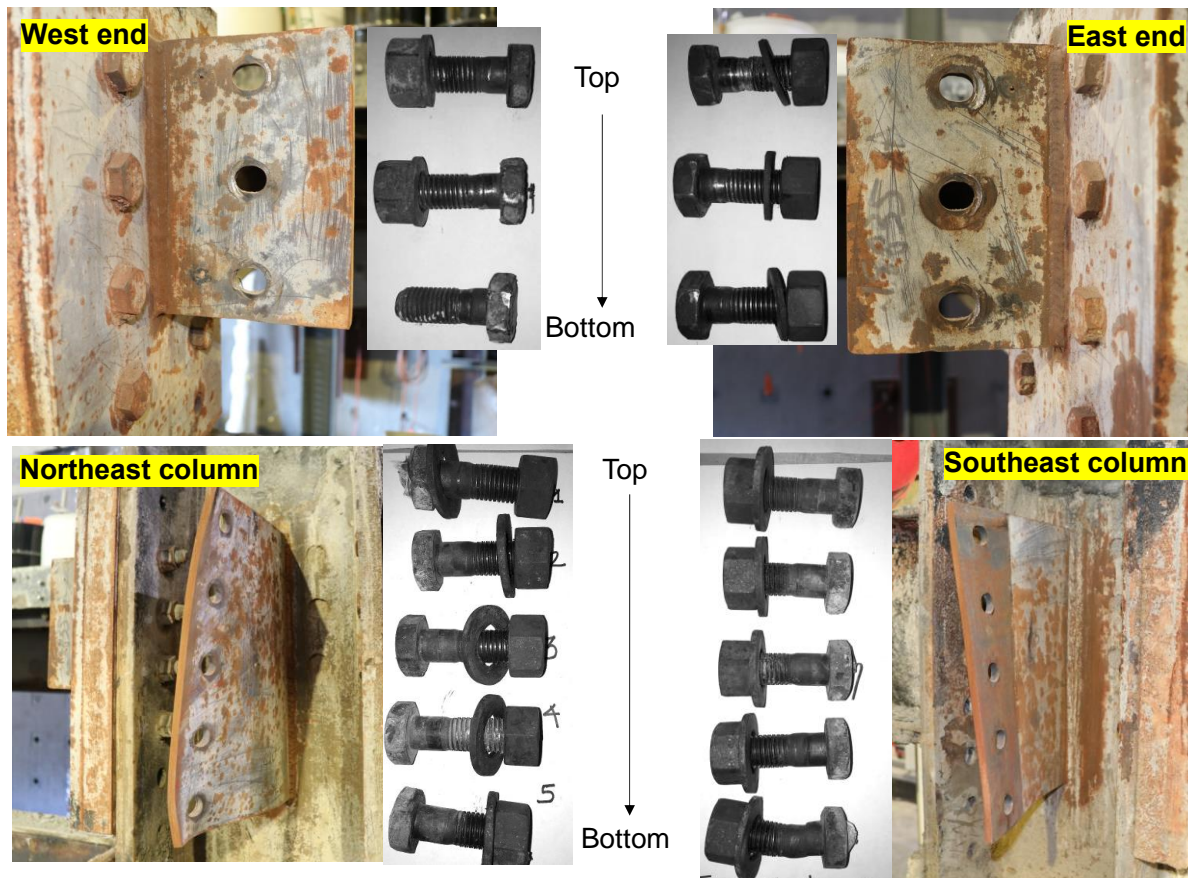
Fig. 38. Post-test photographs of the standard shear tab connections of the north edge beam (top) and the extended shear tab connections of the east girder (bottom).

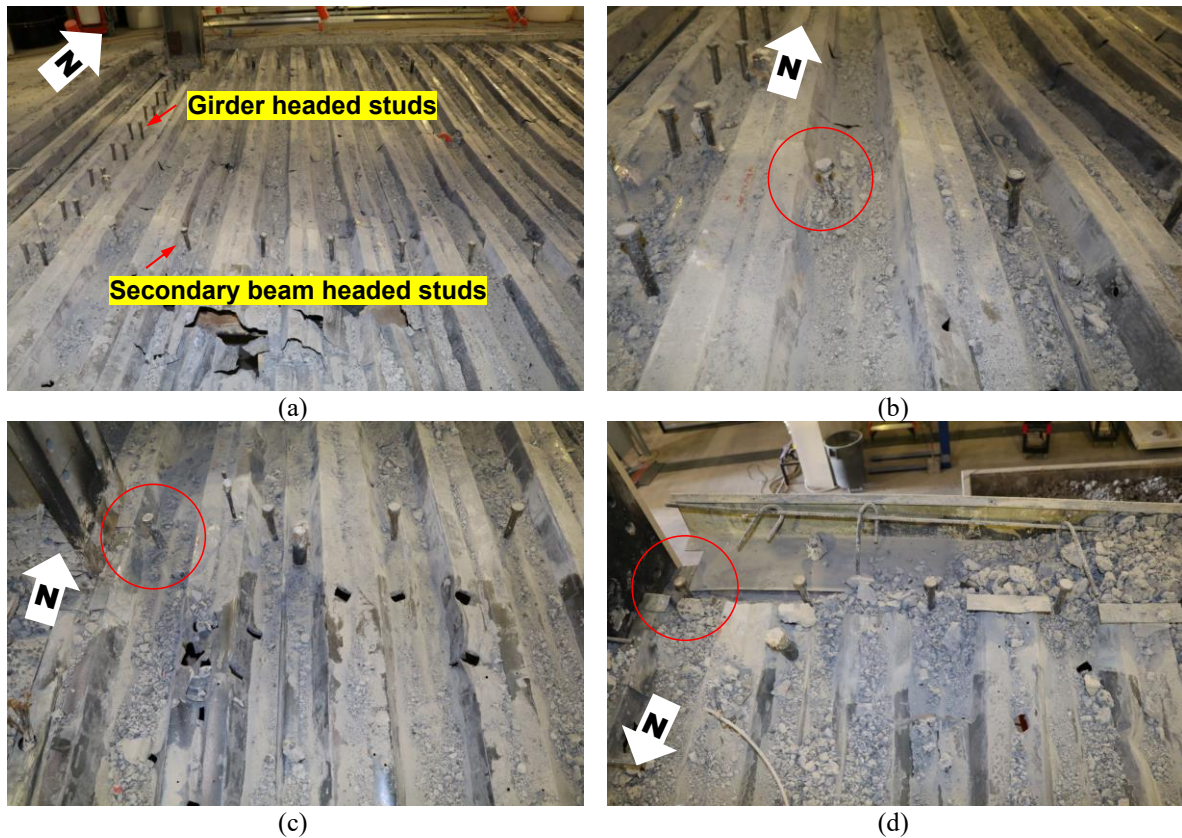
Fig. 70. Post-test photographs of headed studs after concrete removal: (a) Northwest steel decking; (b) Secondary beam; (c) North edge beam; (d) South edge beam. The beam-end stud is in a red color ring.

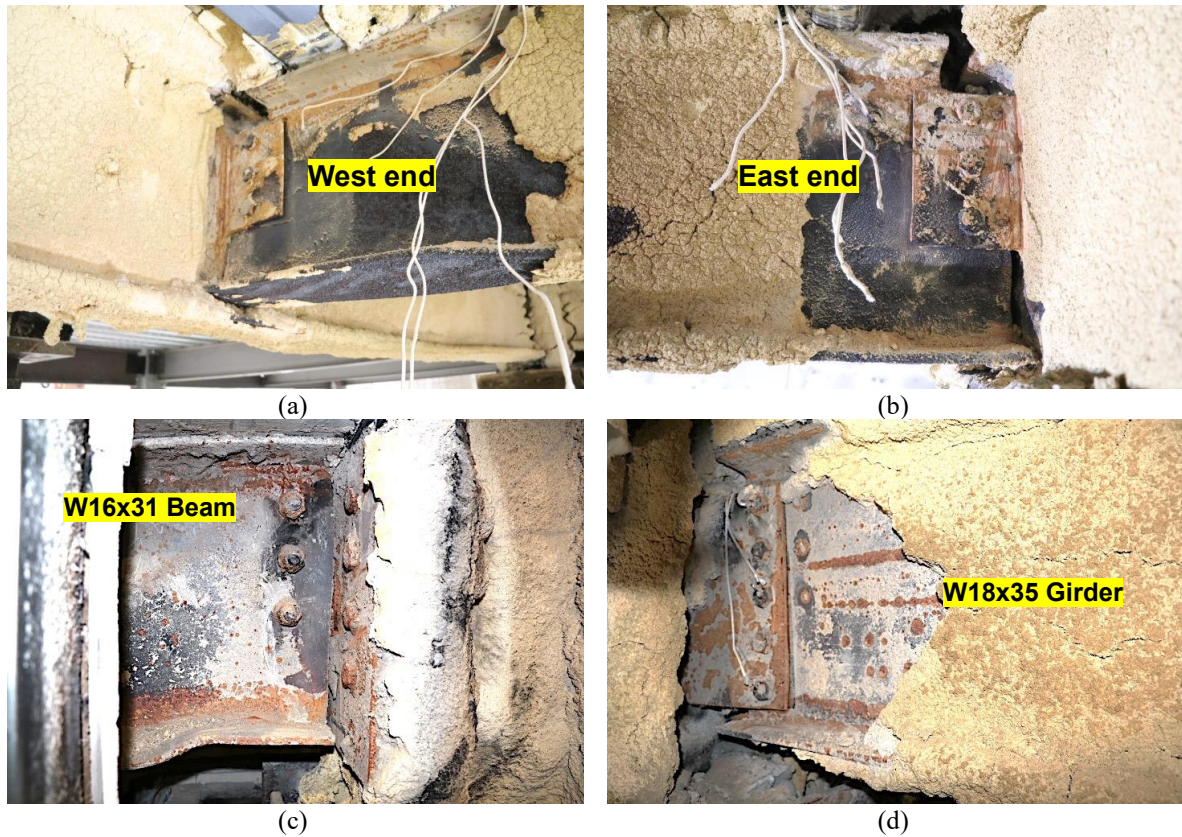
Fig. 71. Post-test photographs of shear tab connections: (a-b) secondary beam, (c) north beam, and (d) east girder. Fireproofing was removed manually.

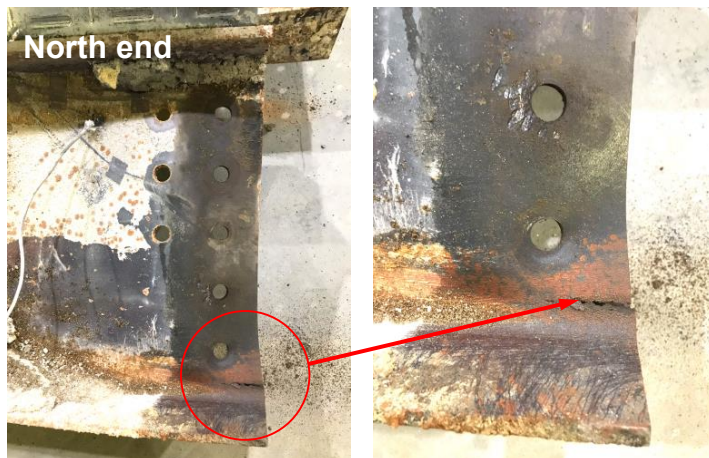
Fig. 76. Post-test photographs: West girder with rupture of the bottom web toe.
