Understanding High Energy Arcing Faults

Course No: E05-018
Credit: 5 PDH

This course was adapted from the NIST U.S. Department of Commerce, Publication No. NIST TN 2290, “Report on High Energy Arcing Fault Experiments”, which is in the public domain.

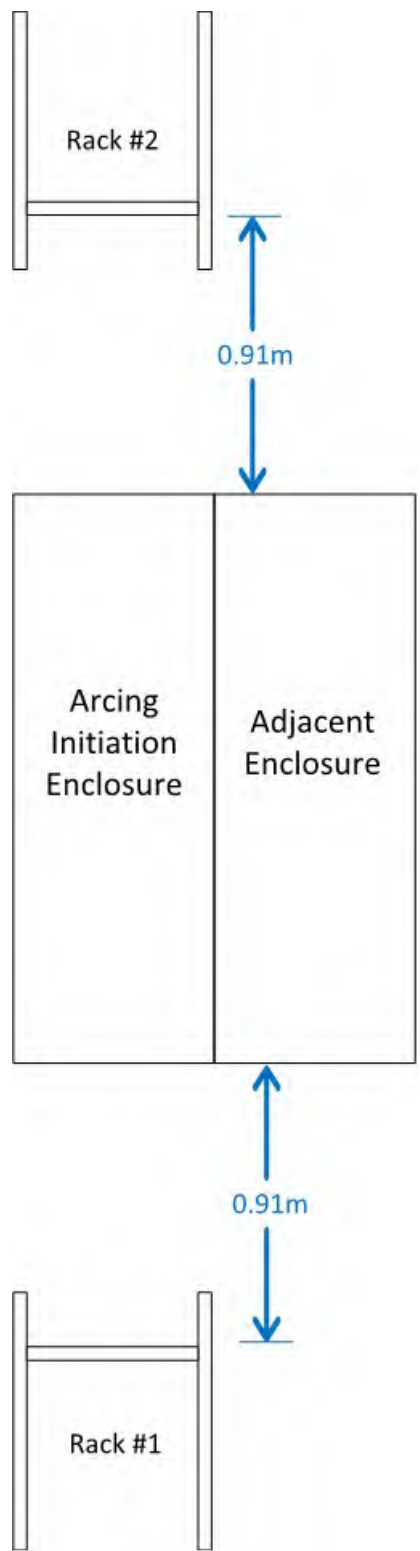
Fig. 23. Generalized plan view of instrument rack configuration around electrical enclosure. See Appendix A.3 for experiment specific instrumentation rack locations. Note that horizontal Rack #3 located above “Arcing Initiation Enclosure” is not shown, see elevation view in Fig. 24 for location.

The thermal instrumentation devices were located on instrument racks with the face of the instruments located approximately 0.91 m (3.00 ft) from the exterior of the metal-clad enclosure. This location was selected to be consistent with historical experiments that focused on confirming the hazard zone of influence. In all medium-voltage switchgear experiments an instrumentation rack was also located above the enclosure. This instrumentation rack (Rack #3) was secured to the electrical enclosure with 90-degree angle red GPO-3 board (glass reinforced thermoset polyester) and nominal ¼ in-20 fasteners. The sensors on Rack #3 were located approximately 0.91 m (3.00 ft) from the top of the enclosure's metal cladding. Illustration of instrumentation rack configurations are shown in Fig. 23 and Fig. 24. A photograph shows the instrumentation racks around the experimental device during setup in Fig. 25. Minor variations of instrumentation rack placement did occur among experiments and details of the exact instrument location for each experiment are presented in Appendix A. Low-voltage switchgear experiments did not use a horizontal instrumentation rack above the enclosures. The expanded uncertainty in the measurement of the distances from the instrumentation racks to the electrical enclosure is ± 13 mm (0.5 in) with a coverage factor of 2 and an estimated confidence interval of 95 percent.

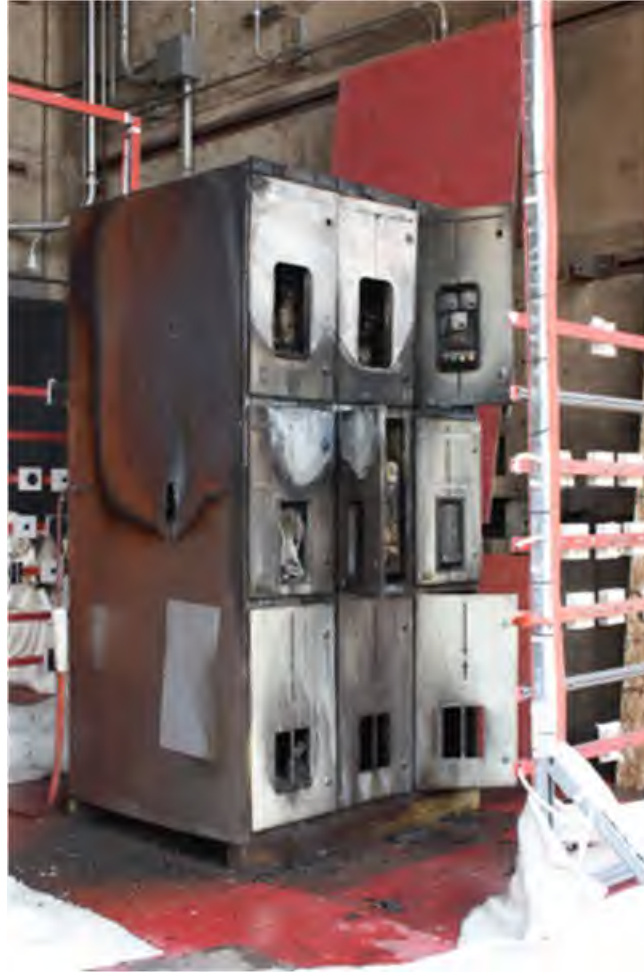
Fig. 37. Enclosures Post-Experiment 2-33B. Note the external breach on the middle side panel of Enclosure 'C'.

A photograph of the enclosures following the experiment is presented in Fig. 37. The enclosures did experience a breach on the exterior and internal panel of Enclosure 'C' (EV53). Internal panels also experienced damage and material loss. The internal breach mass loss was estimated at approximately 283.0 g and the exterior mass loss was estimated at approximately 61.8 g. Detailed photos are provided in Appendix D.

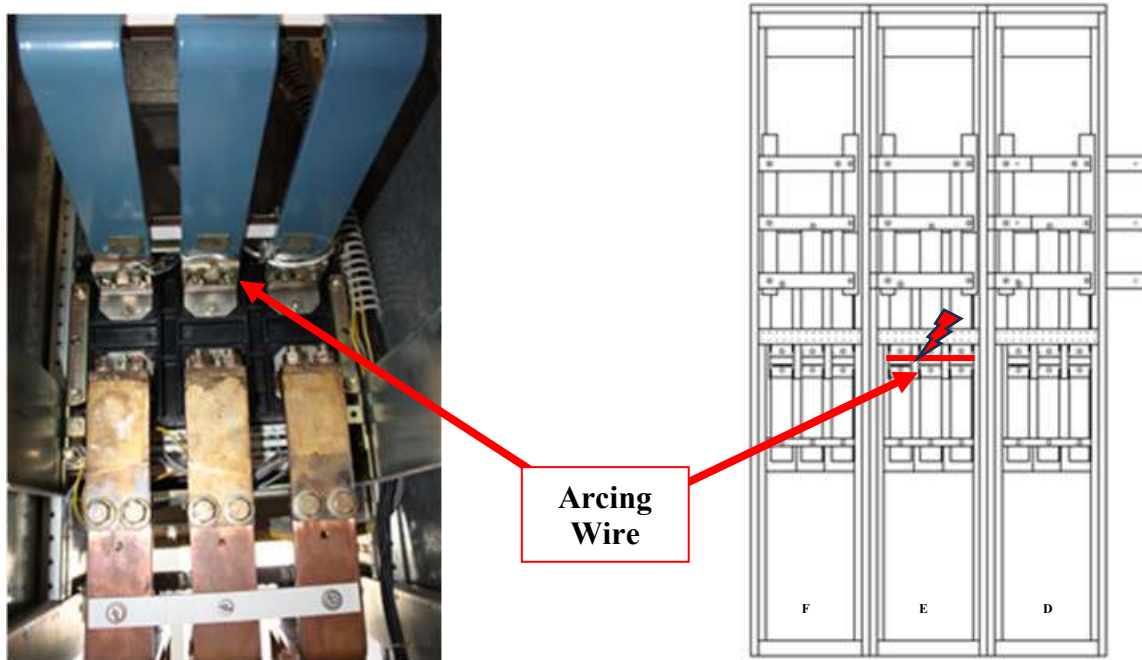
Fig. 40. Experiment 2-34 configuration. Left – photo of arcing wire (#10 AWG) installed, Right – drawing of internal bus work showing location of arc initiation.

Experiment 2-34 used a configuration similar to experiments 2-33A and 2-33B. However, instead of just three enclosures, an additional the unit lineup configuration was used with both lineup configurations placed back-to-back. In total six units were used. Enclosures EU51 (“D”), EU52 (“E”) and EU53 (“F”) were in one lineup configuration with the arc initiating in unit EU52. The additional three Enclosures EV51 (“A”), EV52 (“B”), and EV53 (“C”), were placed behind in the “back-to-back” configuration (Fig. 6). The arc wire was located at the upper vertical bus bars at the connection point to the breaker in the middle Enclosure EU52 (“E”). These bus bars connect the breaker to the main bus. The arcing wire was installed between all three phases and marked-up illustrations of the arc wire location is presented in Fig. 40.

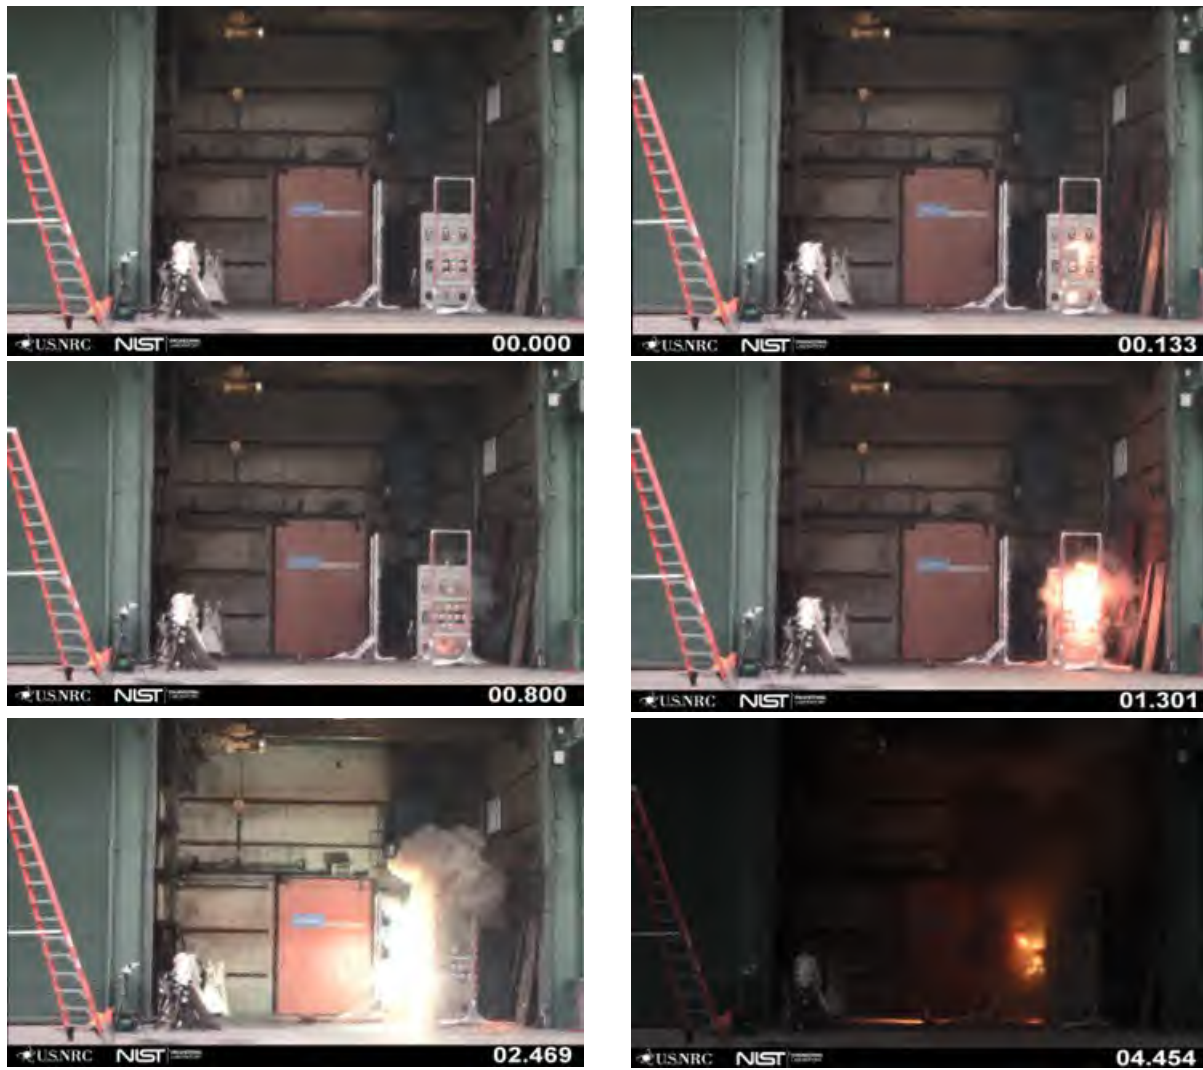
Fig. 41. Sequence of Images from Experiment 2-34 (image time stamps are in seconds).

Time (ms)	Observation
0	Initial light observed
133	Center-Mid Door opens
800	Arc eject observed above enclosure
1 301	Fire exiting Center-Mid cubicle
2 469	Arc breach to side panel
4 454	Smoke begins to clear cell after end of arc

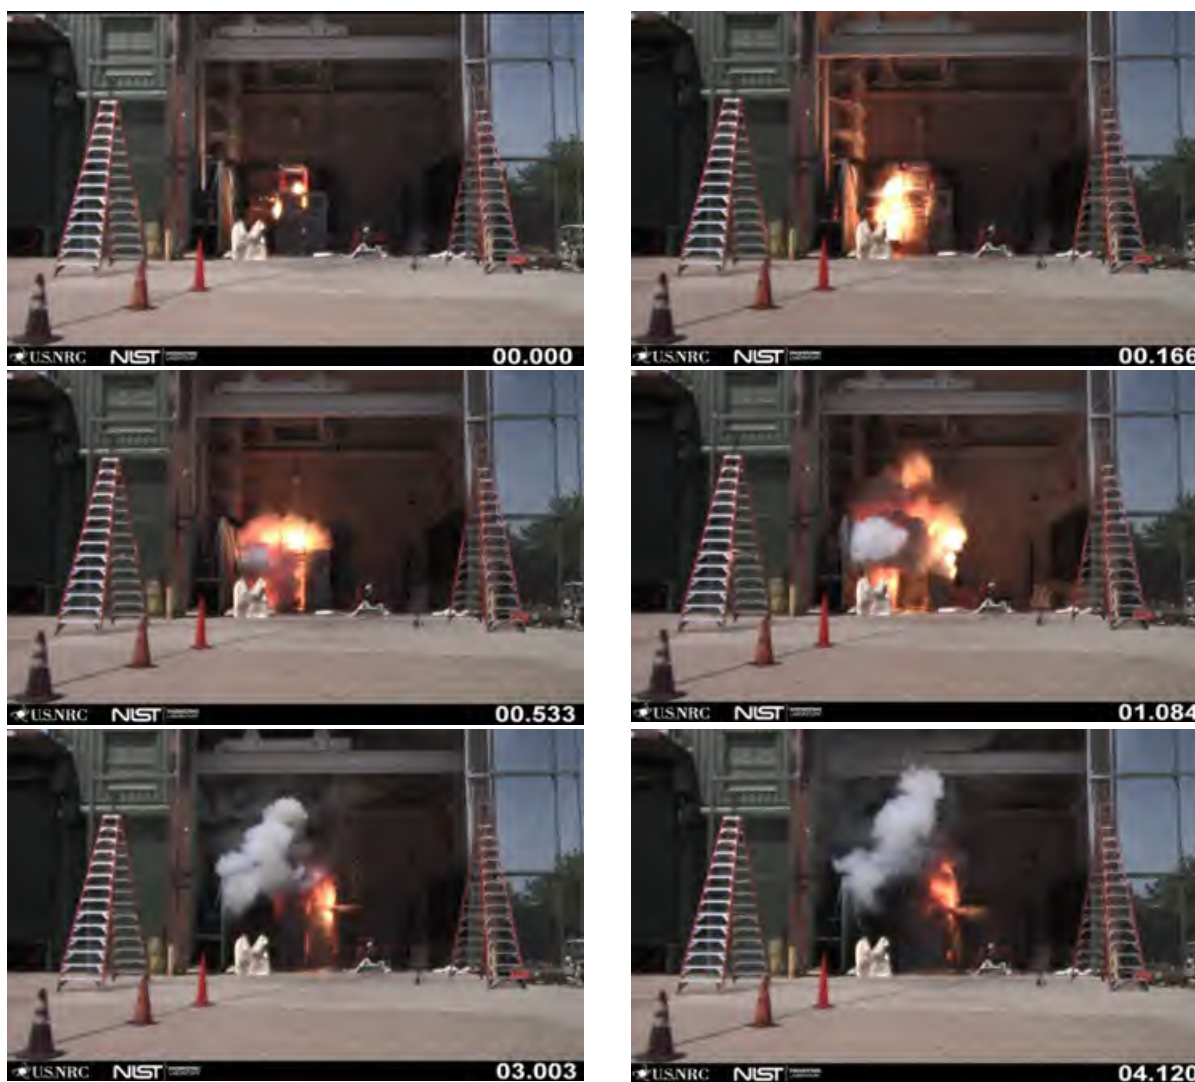
Fig. 47. Sequence of Images from Experiment 2-35 (image time stamps are in seconds).

Time (ms)	Observation
0	Initial light observed
166	Door begins to open
533	Arc ejecta exiting top of left enclosure
1 084	Arc migrates to right enclosure
3 003	Flaming from left enclosure and arcing in right enclosure
4 120	End of arc

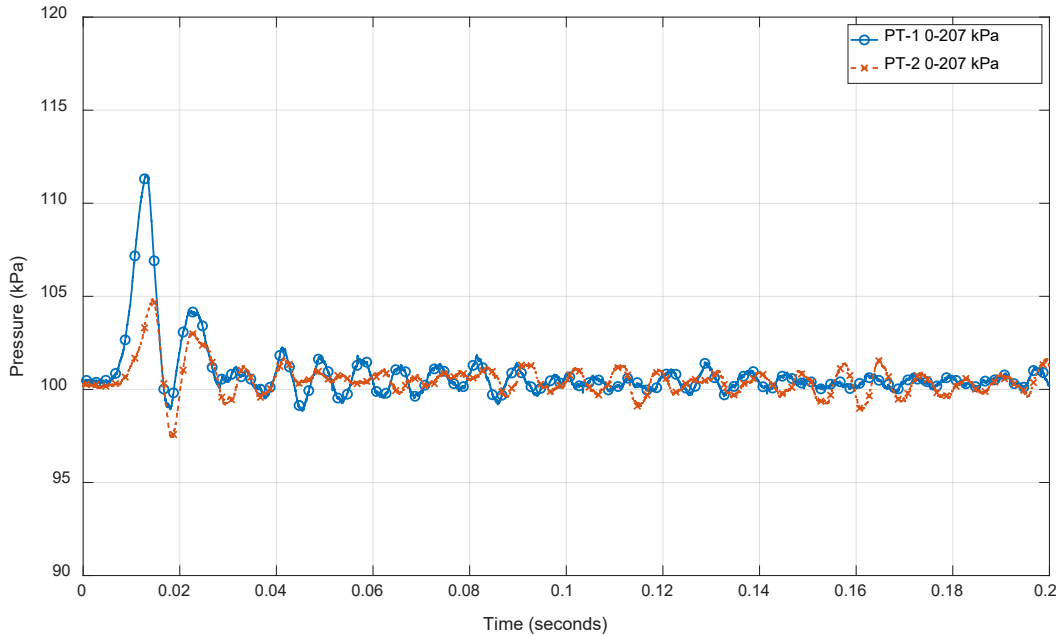
Fig. 51. Pressure measurements from Experiment 2-35. Measurement uncertainty ± 3 percent.

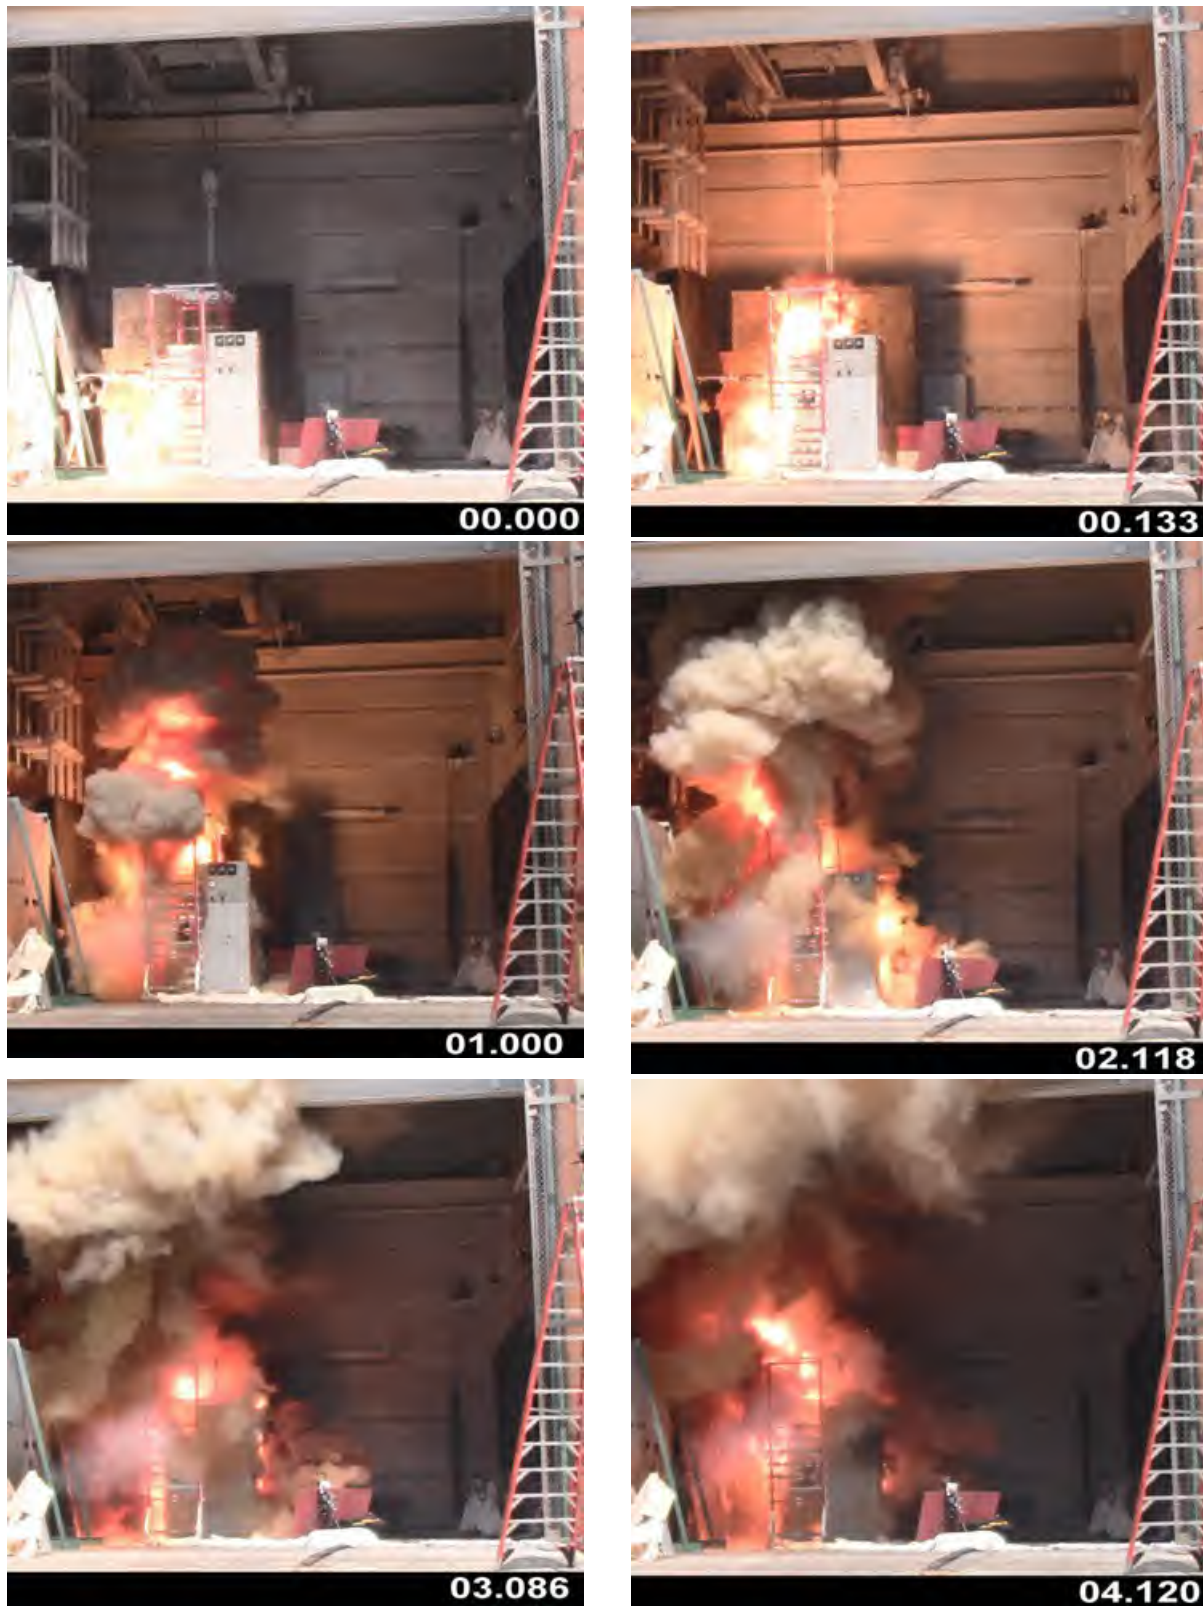
Fig. 53. Sequence of Images from Experiment 2-36 (image time stamps are in seconds).

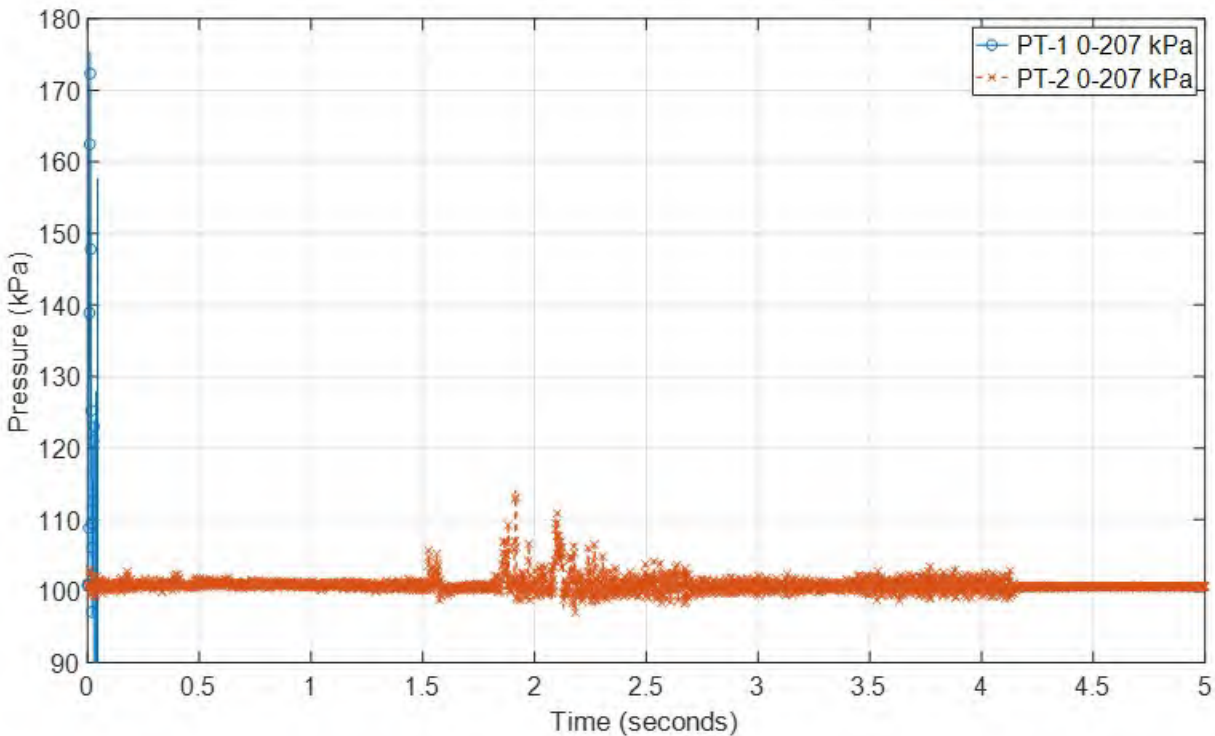
Fig. 57. Pressure measurements from Experiment 2-36. Measurement uncertainty ± 3 percent. Note that pressure probe “PT-1” and its cable were physically damaged during the experiment, and PT-1 data after approximately 0.023 s is not valid.

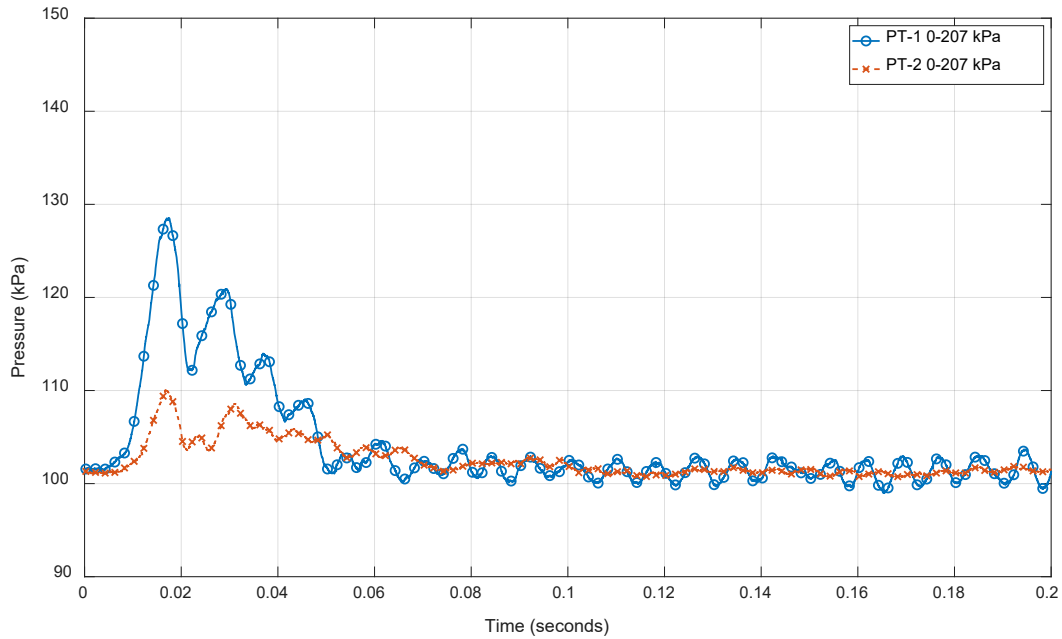
Fig. 71. Pressure measurements from Experiment 2-38. Measurement uncertainty ± 3 percent.

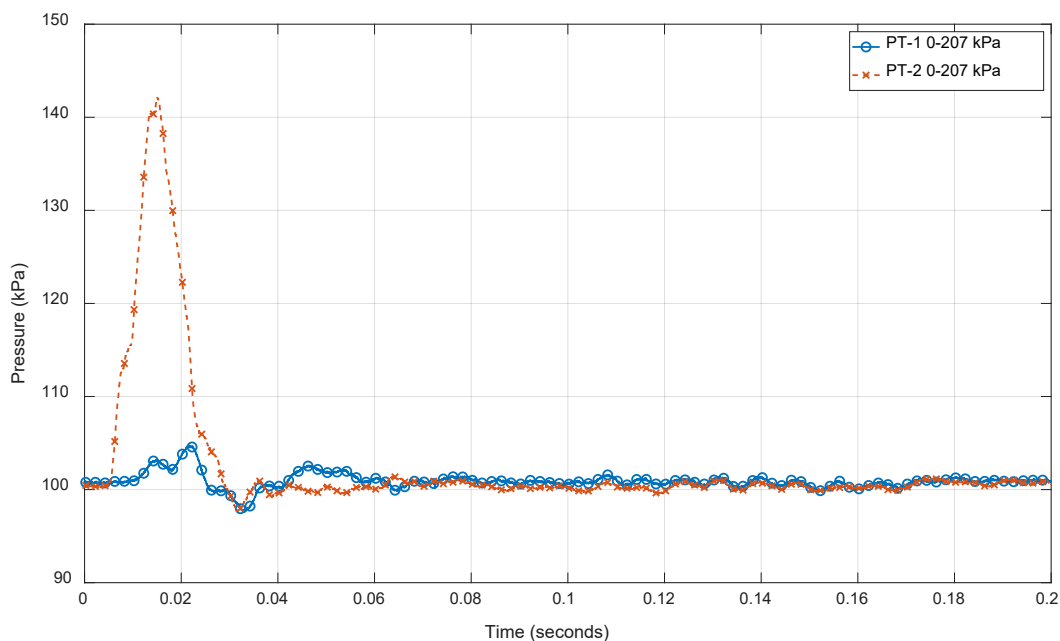
Fig. 77. Pressure measurements from Experiment 2-39. PT-1 Enclosure “I”, PT-2 Enclosure “M”. Measurement uncertainty ± 3 percent.

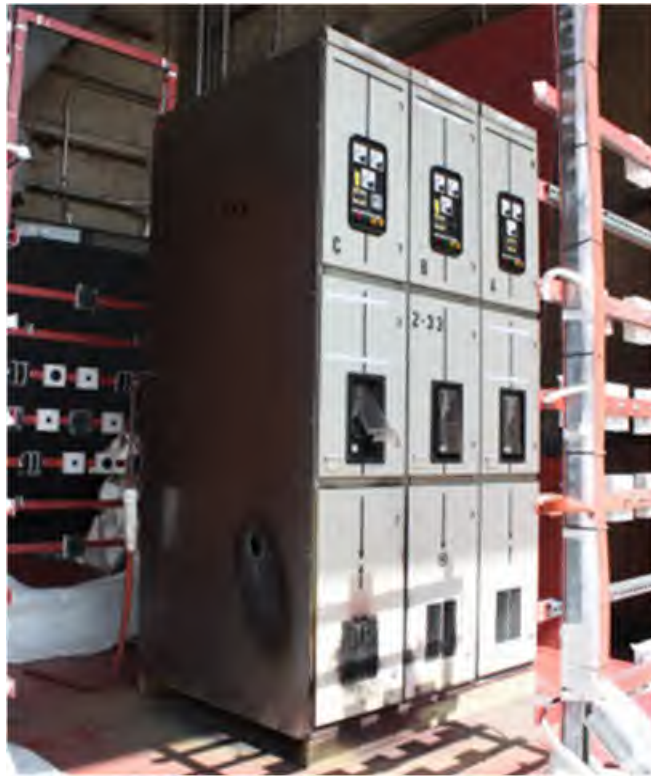
Fig. 162. Post-Experiment 2-33A. Note arc burn-through on side of Enclosure "C" (EV53), melting of vents in lower section and placement of breaker protection cover.

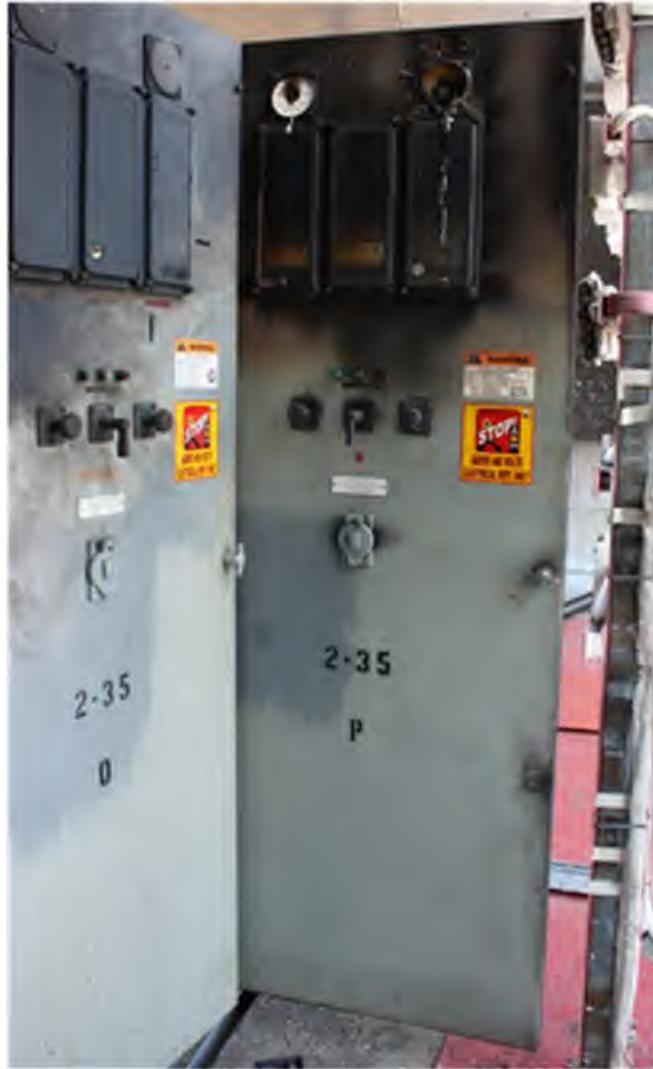
Fig. 180. Post-Experiment 2-35 Enclosures “O” and “P”. Soot and heat damage on front enclosure doors.

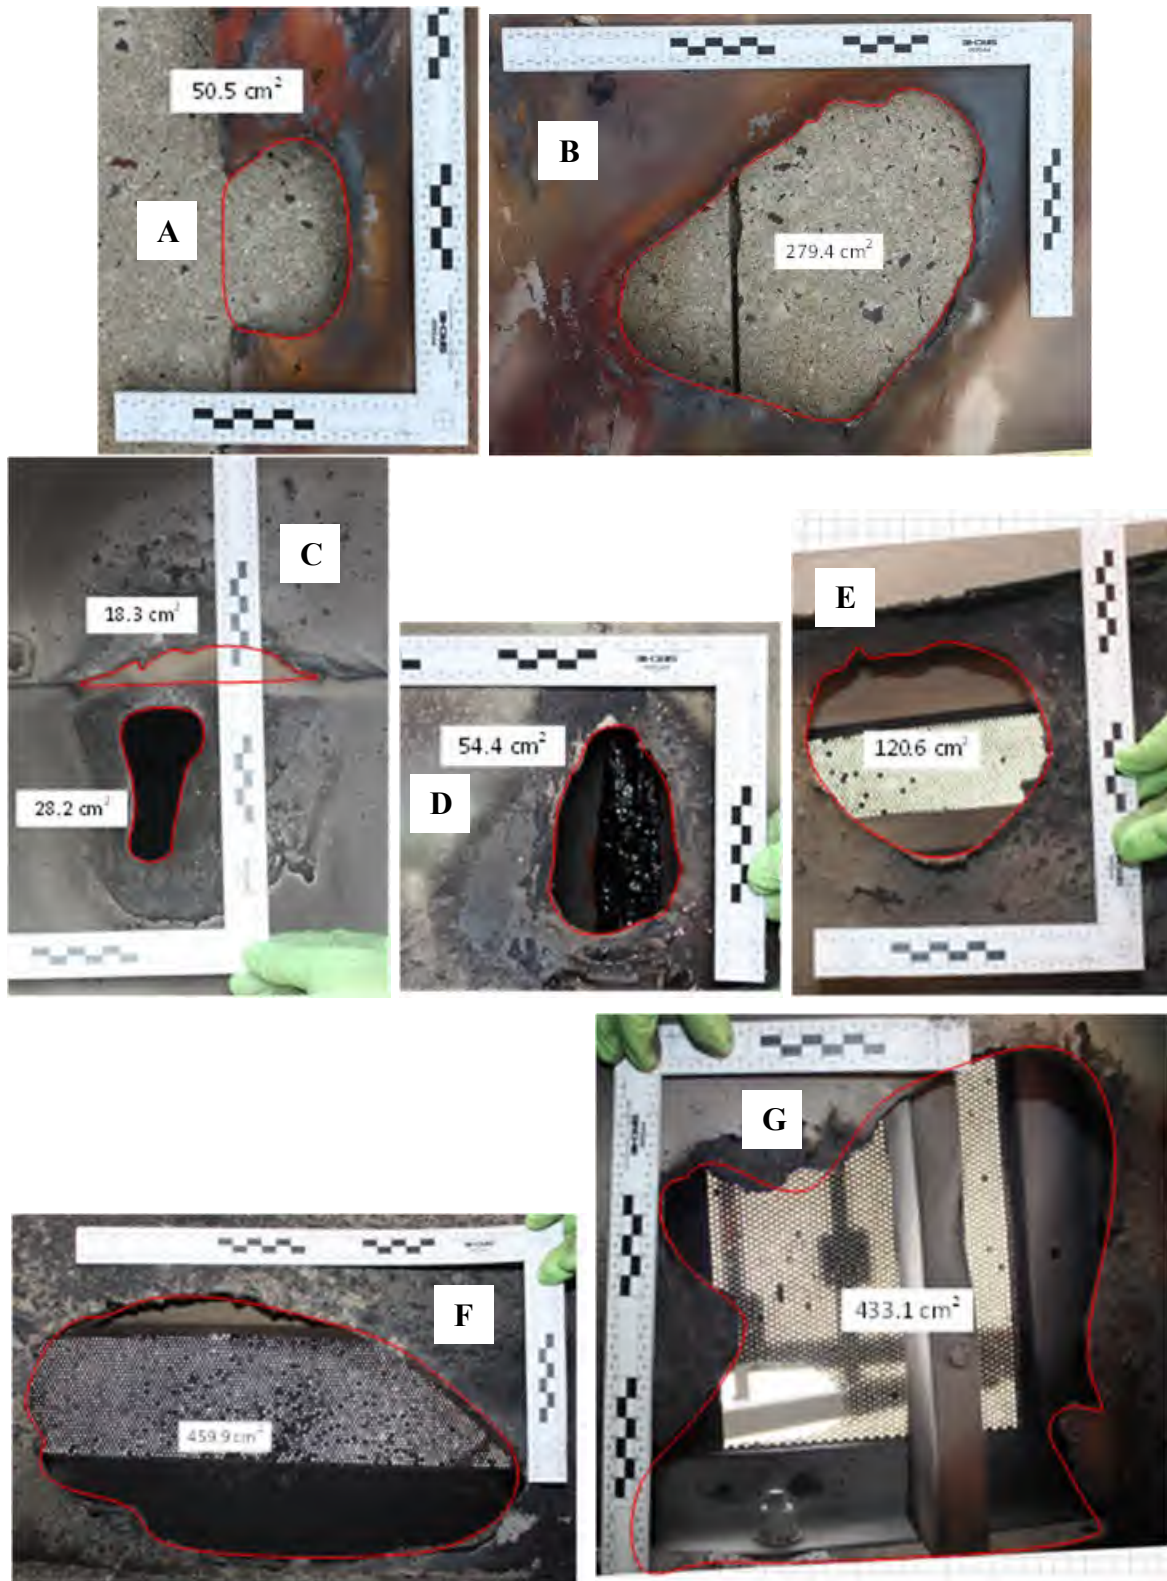
Fig. 181. Post-Experiment 2-35 Enclosure “O” Breaches A-B-C, Internal main bus cover panels, D-E-F-G, Internal panels above breaker.

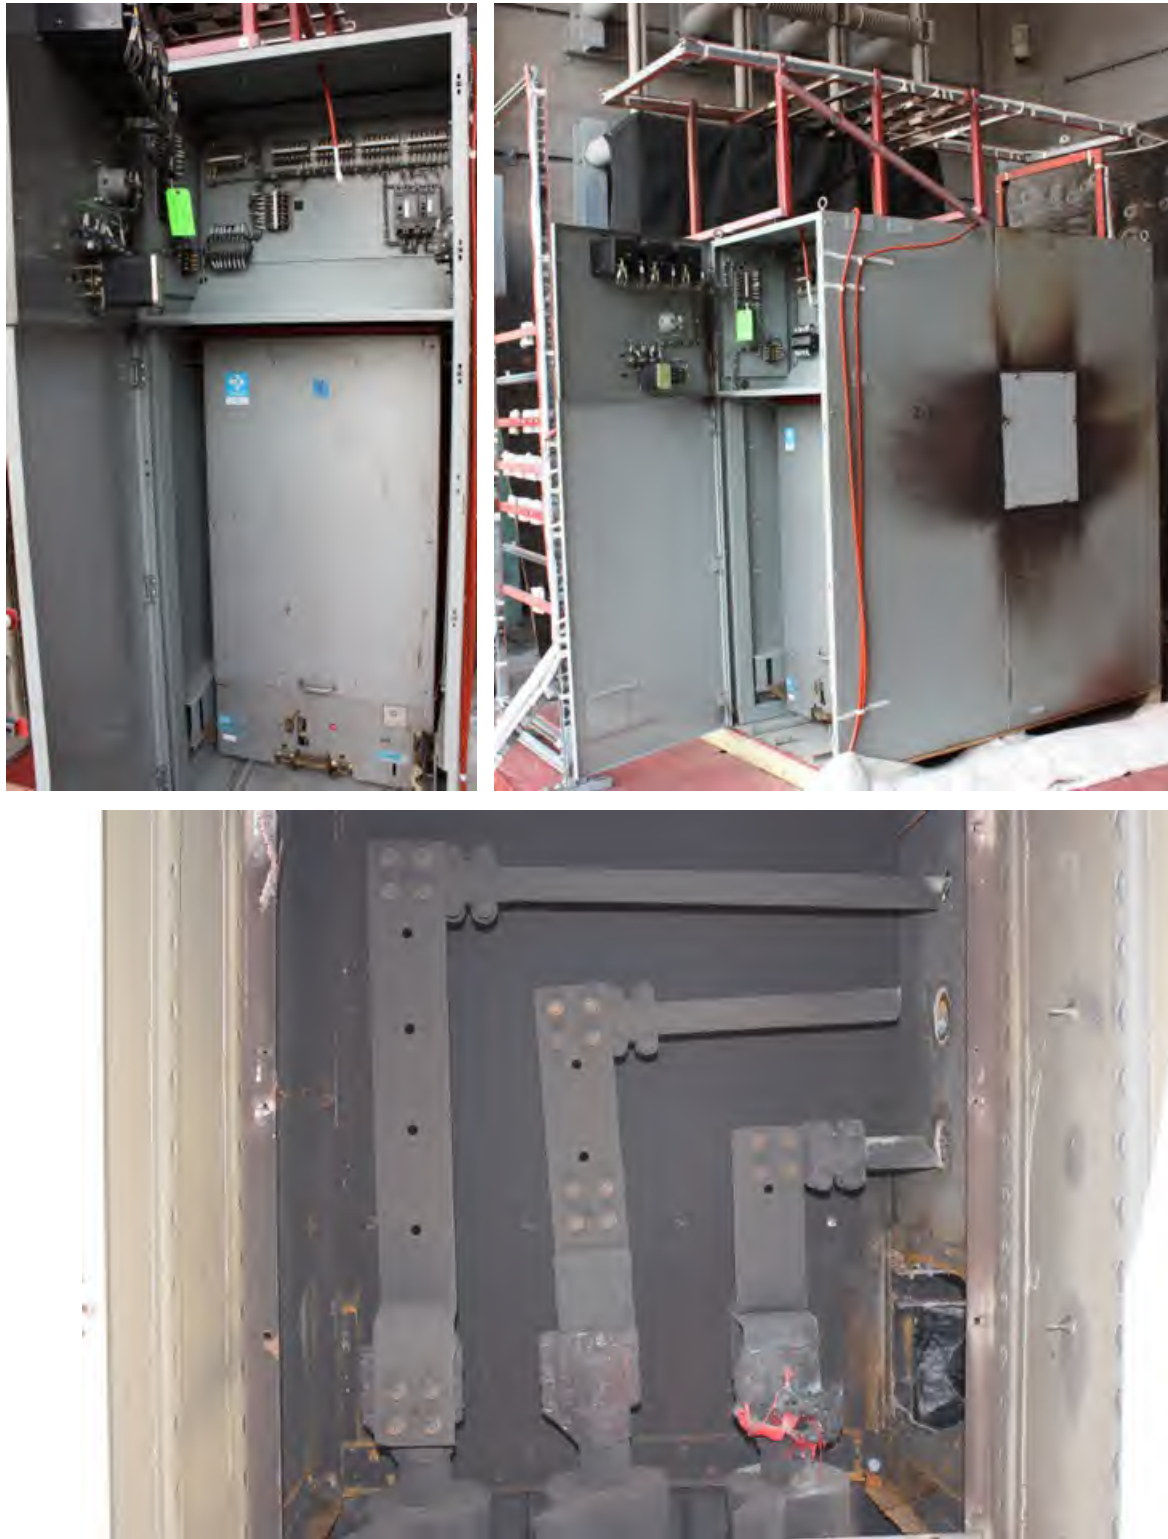
Fig. 184. Post-Experiment Enclosure "N". Top-left – front instrumentation and breaker cubicle, Top-right – side showing soot deposit near cover over main bus section of switchgear, Bottom – main bus section showing damage to horizontal copper bus.

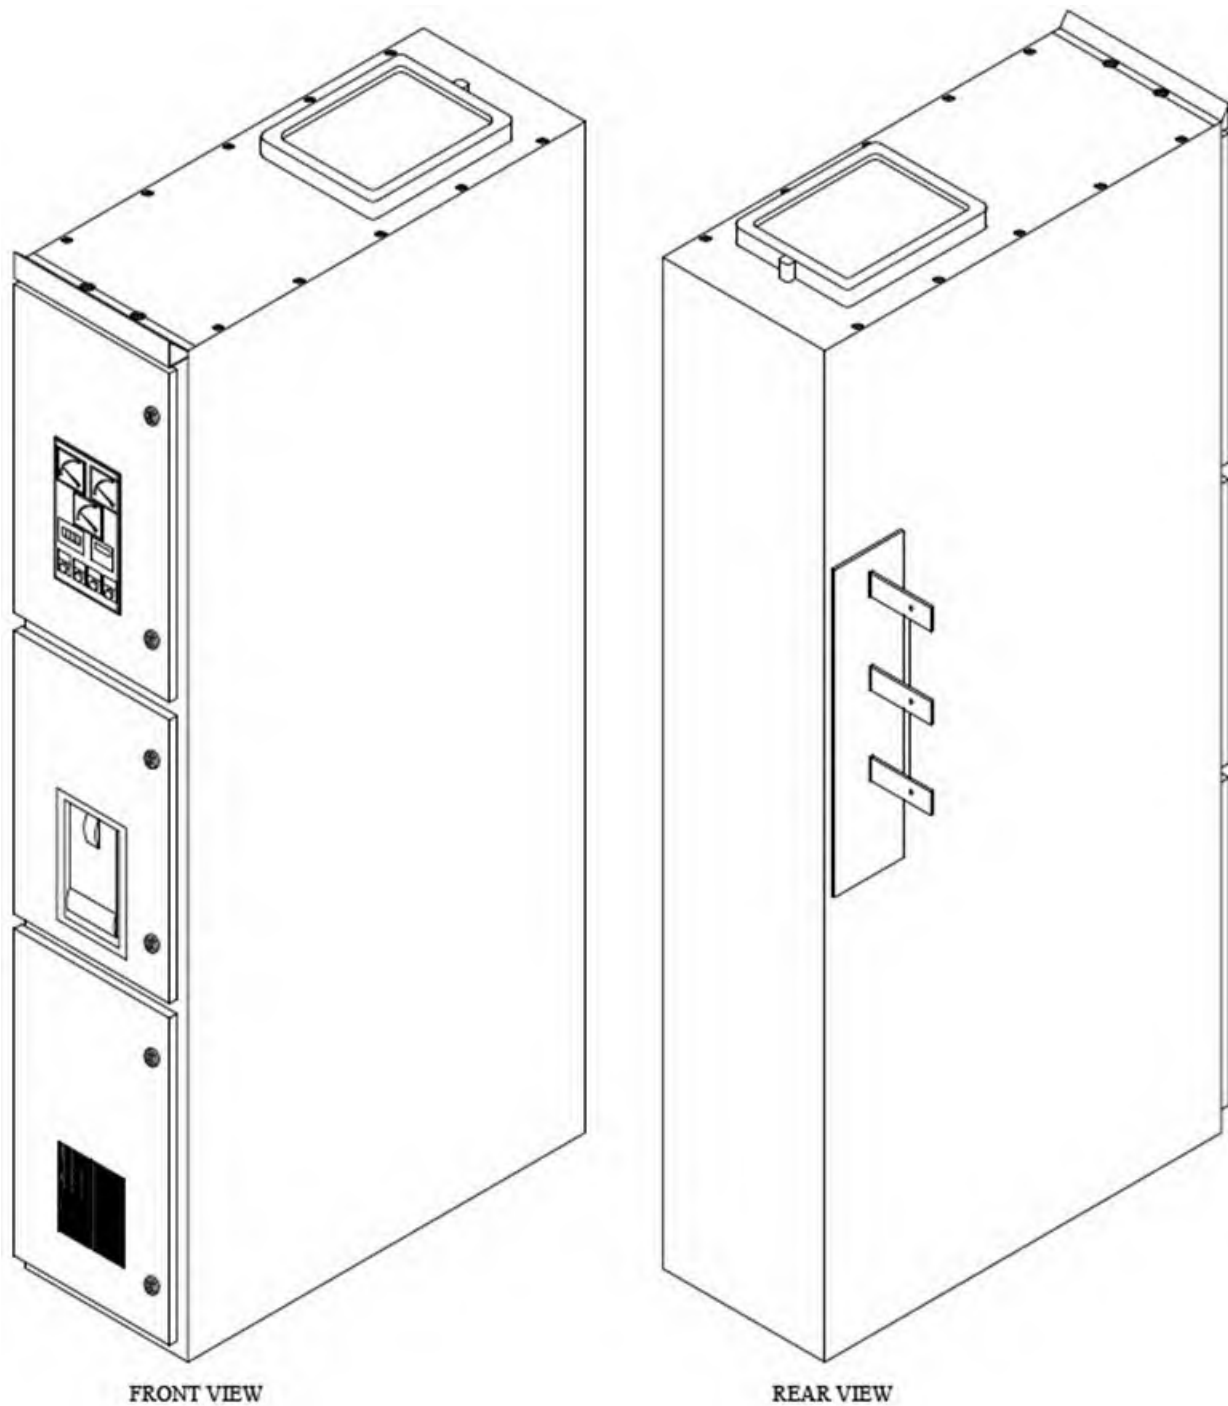
Fig. 209. Isometric drawings of used gear.

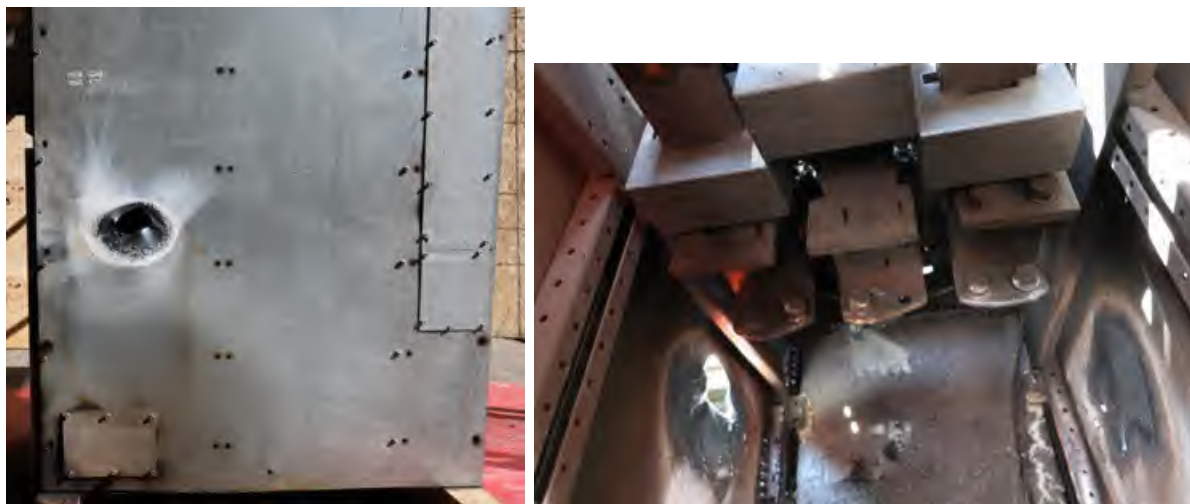
Fig. 215. Post-Experiment 2-XXA. Left – enclosure breach on right side of gear (cladding 1.5 mm [0.060 in] thick), Right – internal bus bar condition at arcing location.

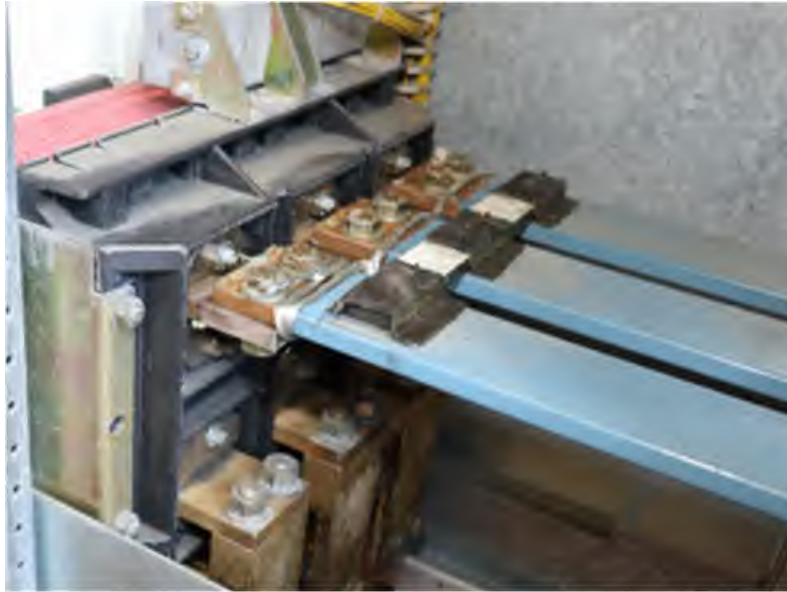
Fig. 219. Pre-Experiment 2-YYA arcing wire location.
