Fire Resilience in Steel-Concrete Structures Part II: Advanced Solutions

Course No: S03-033
Credit: 3 PDH

This course was adapted from the NIST U.S. Department of Commerce, Publication No. NIST TN 2203, “Fire Resilience of a Steel-Concrete Composite Floor System: Full-Scale Experimental Evaluation for Influence of Slab Reinforcement (Test #2)”, which is in the public domain.

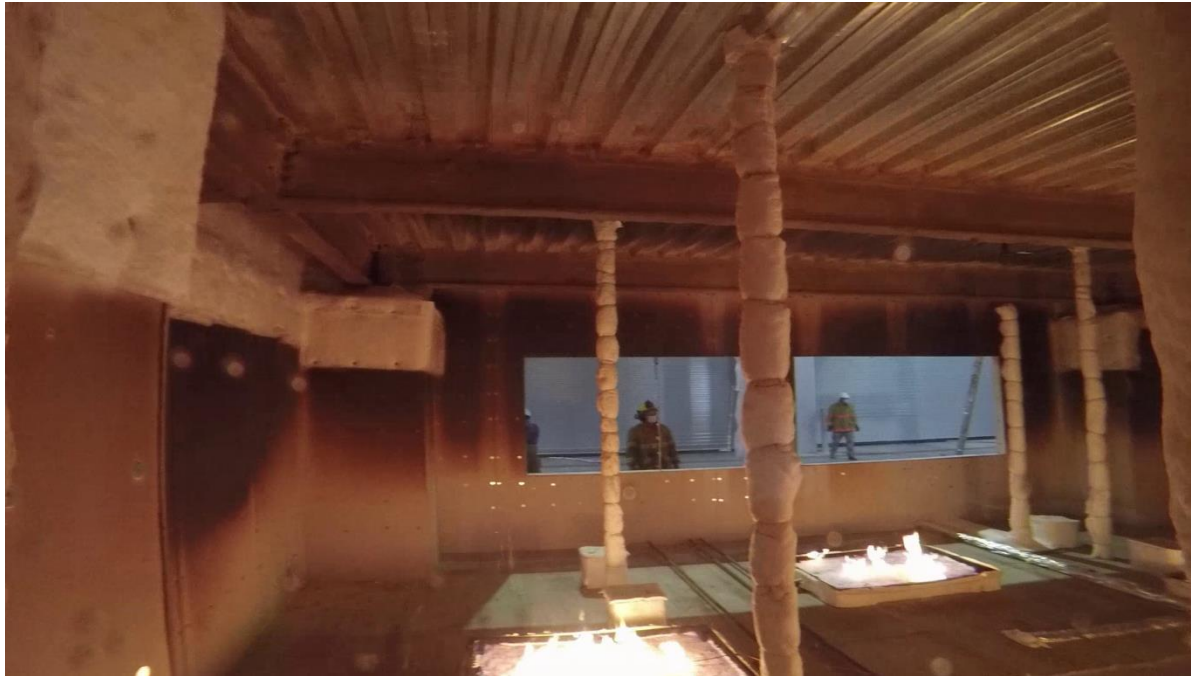
Clock Time	Fire Exposure Time	Description
10:36 AM		Hydraulic loads of actuators began to ramp up
11:25 AM	0 min	The burner ignition was confirmed; See Fig. 14a.
12:45 PM	100 min	A breach became visible along the south wall above the test floor level allowing flame extension; See red circle in Fig. 14b.
1:36 PM	131 min	The burners were switched off
3:38 PM		Hydraulic pressure was released

Fig. 14. Snapshots from the test video showing (a) inside the test compartment at ignition of the burners and (b) top of the test floor specimen at 120 min after the burner ignition.

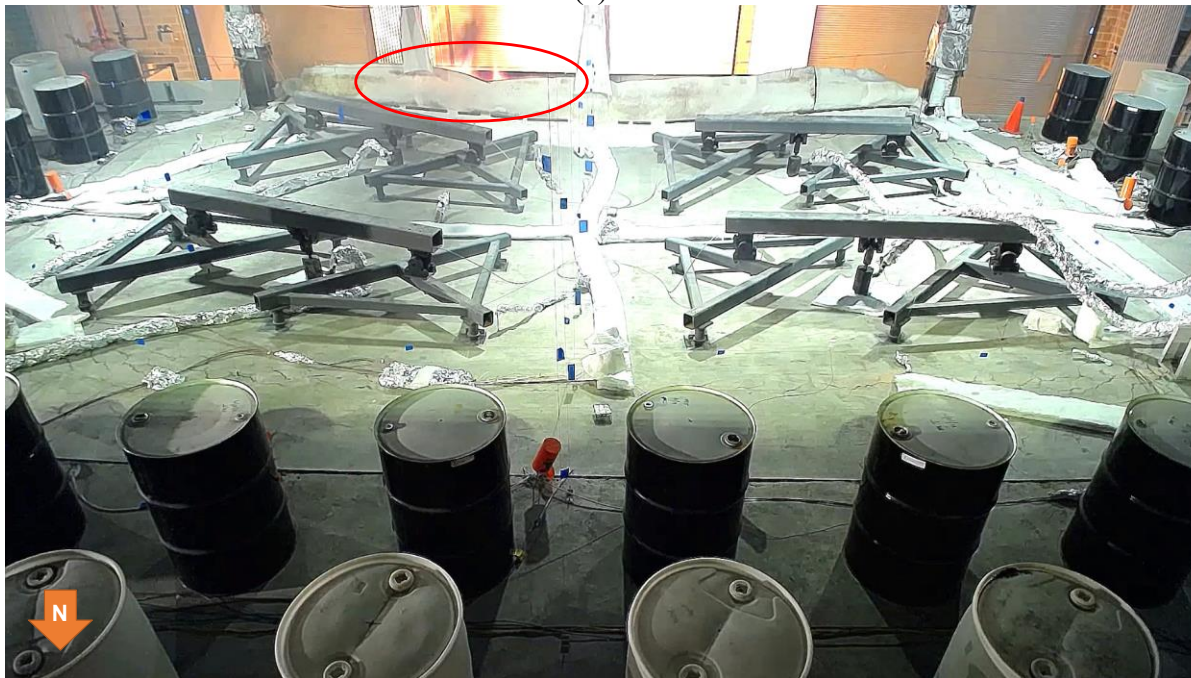
(b)

As shown in Fig. 28, the vertical displacement of the secondary beam at midspan (VD5) increased to 455 mm (equivalent to the ratio $L/20$ where $L = 9.1$ m) at 131 min, finally reaching its peak value of 475 mm at 145 min (i.e., about 14 min into cooling). The maximum displacements of the north beam (VD1), the east girder (VD7), and the west girder (VD11) were 200 mm, 115 mm, and 125 mm, respectively. The vertical displacements of the south edge beam at midspan (VD10) became invalid after 130 min because Kaowool strips placed along the south wall were flipped over a measurement string of this displacement sensor as the south wall significantly bent toward the south (Refer to Fig. 14b).

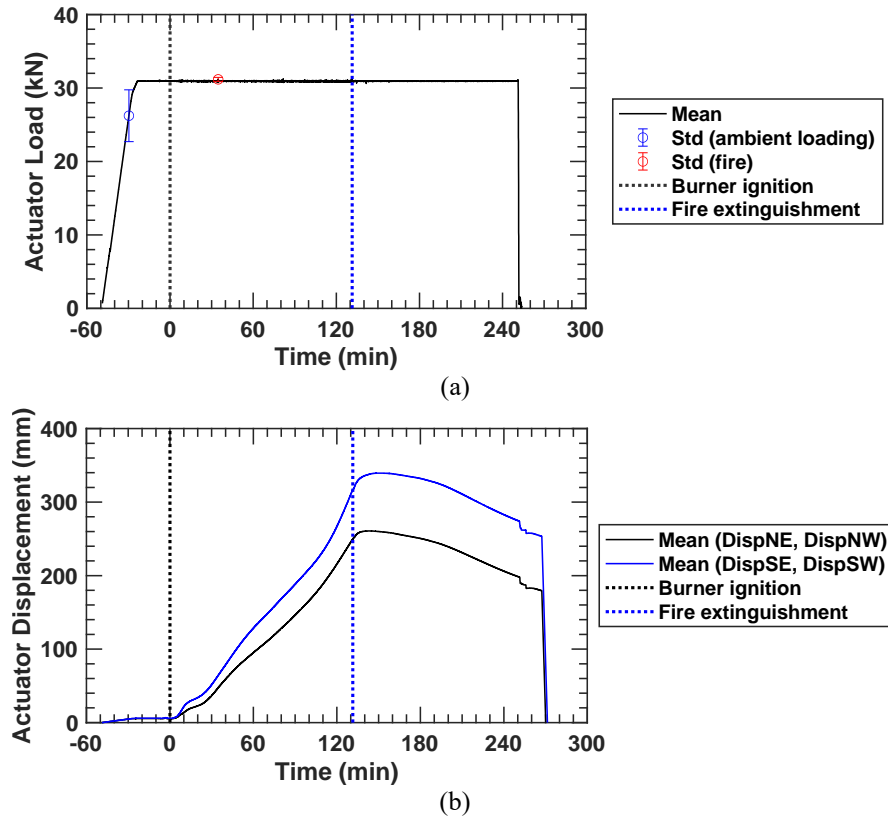
As shown in Fig. 15b, the north half of the test floor slab loaded by the NE and NW actuators exhibited smaller displacements throughout the test period due to slab continuity to the north surrounding bay. The result indicated that the boundary (support) conditions of the test floor assembly was maintained symmetrical about its north-south (transverse) centerline. The maximum variation in actuator displacement values was estimated 5 mm between the NE and NW actuators and 2 mm between the SE and SW actuators.

Fig. 15. (a) Average load applied by a single actuator and (b) stroke displacement of the north actuators (DispNE and DispNW) and the south actuators (DispSE and DispSW).

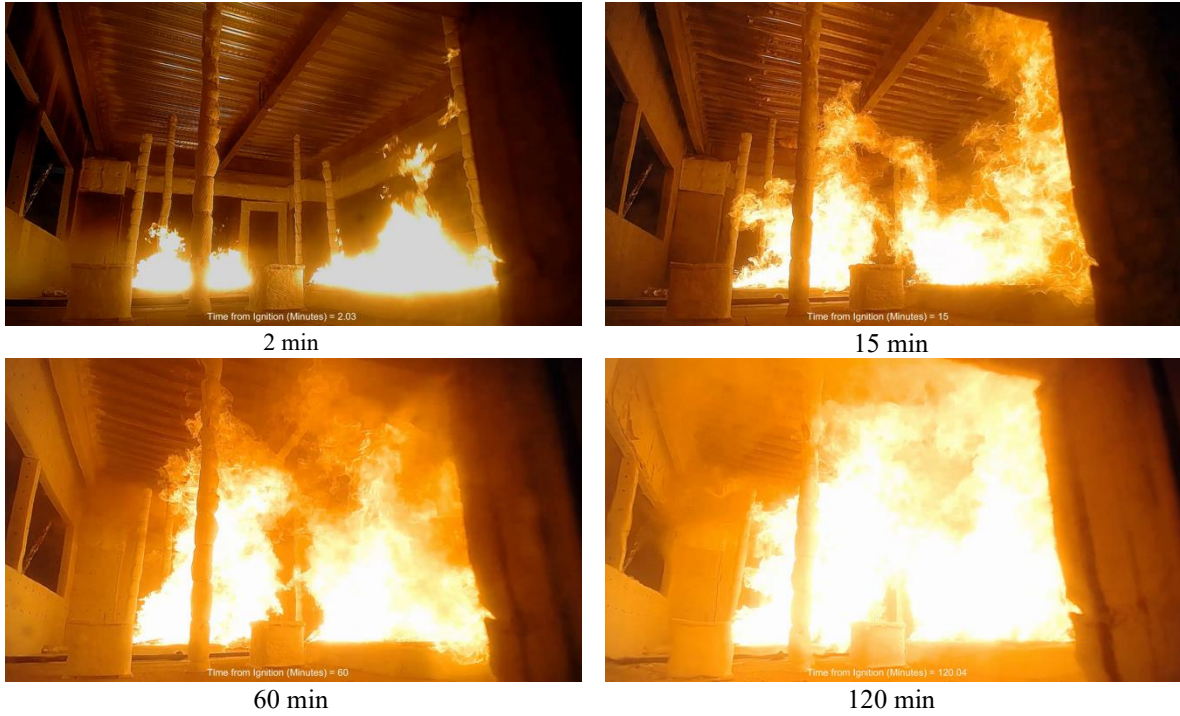
Fig. 17. Snapshots of the video showing inside the test compartment with the times recorded following the burner ignition.

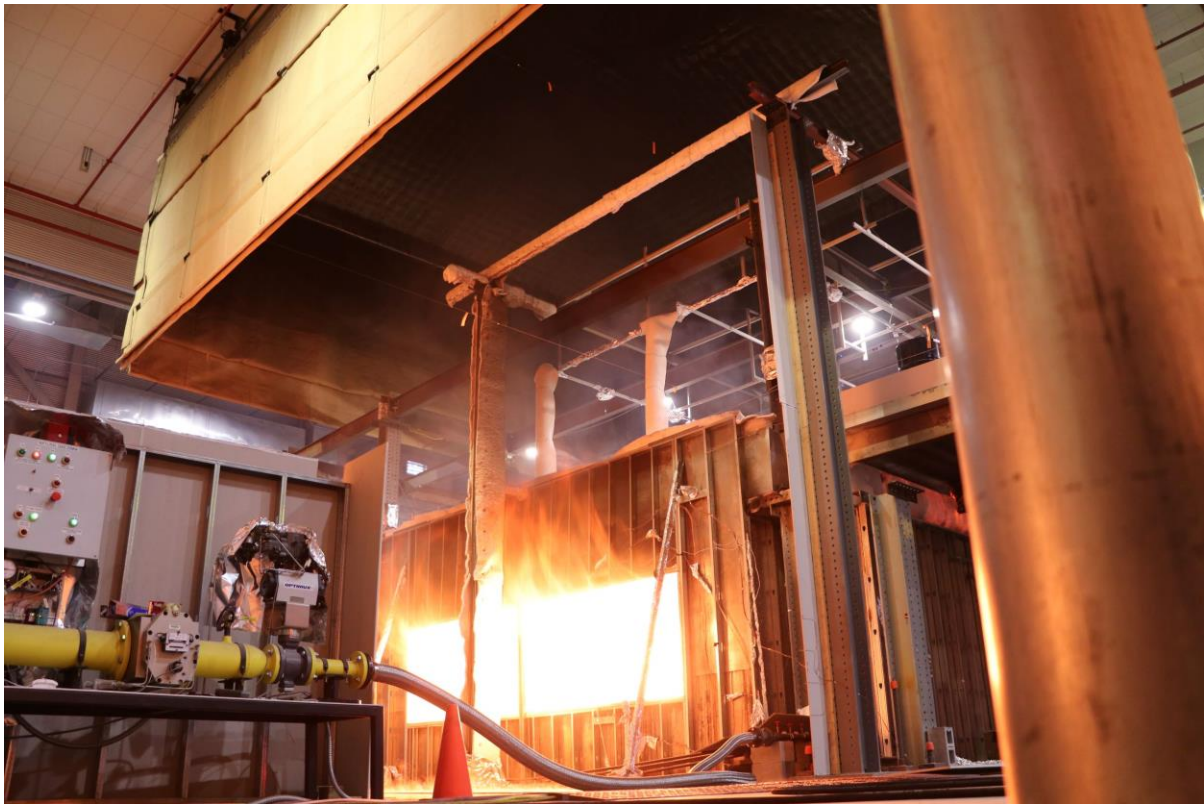
Fig. 18. Front view of the main vent opening of the fire test compartment during Test #2.

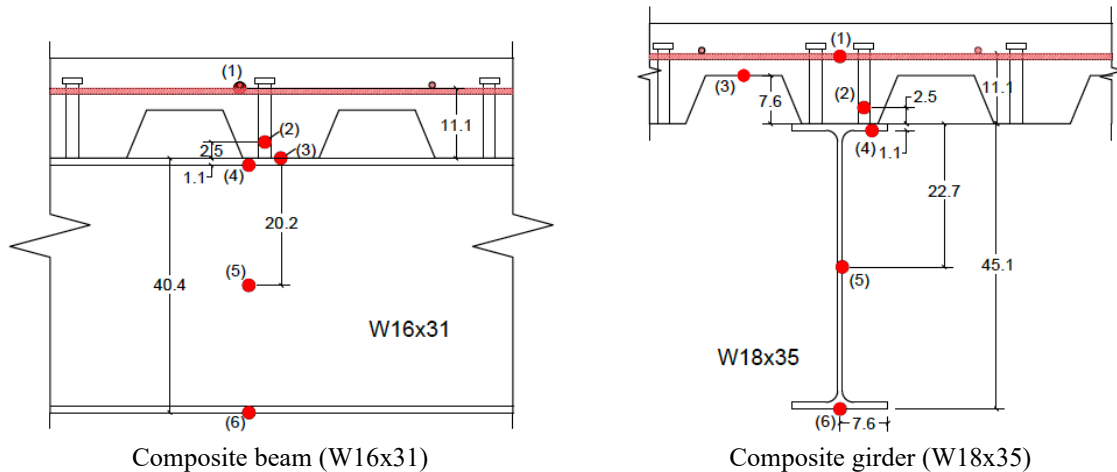
Fig. 22. Locations of thermocouple probes within the 9.1 m composite beam and the 6.1 m composite girder at midspan. Dimensions are in cm.

Temperatures of the 9.1 m span composite beams and 6.1 m span composite girders within the fire test bay were measured across the midspan cross section, as shown in Fig. 22. Temperatures of all five SFRM-protected steel beam shapes and the topping slab are reported in Appendix A.5 and A.6.

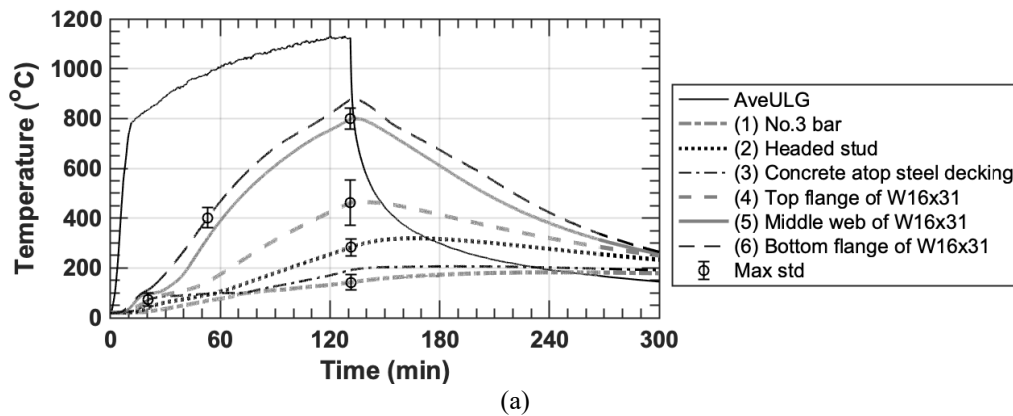
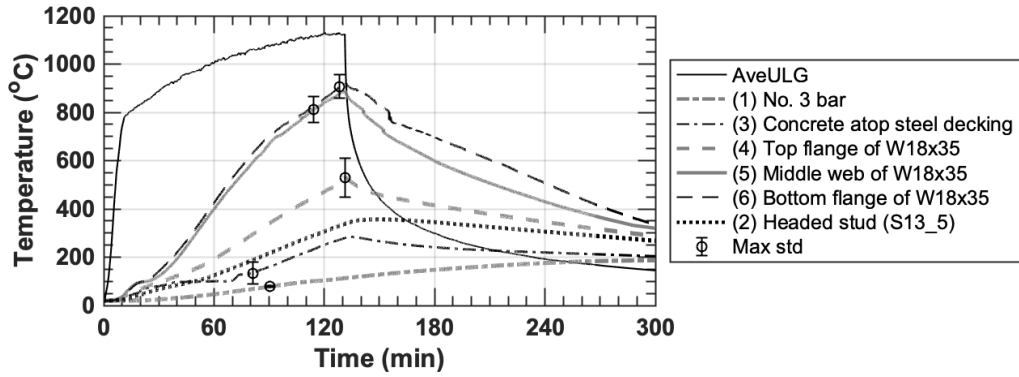
Fig. 23. Average temperatures of (a) 9.1 m composite beam and (b) 6.1 m composite girder at midspan. The error bars indicate the maximum standard deviation of temperature readings at different sections.

The typical temperature change across the composite beam sections is presented in Fig. 23. The 9.1 m composite beam temperatures (Fig. 23a) are the average values of temperature readings of the north, south, and secondary beams at midspan. Similarly, the composite girder temperatures in Fig. 23b are the average temperature values of the east and west girders at midspan. As shown, during the fire exposure, temperatures of the SFRM-applied steel shapes reached a peak value of 850 °C at the bottom flanges and 500 °C at the top flanges on average. Temperatures of the embedded No. 3 reinforcing bars over the beams or girders increased to a peak value of 200 °C after the test fire was extinguished. The greater temperature variation (as large as 20 %) was observed at the top flange or within the concrete slab.

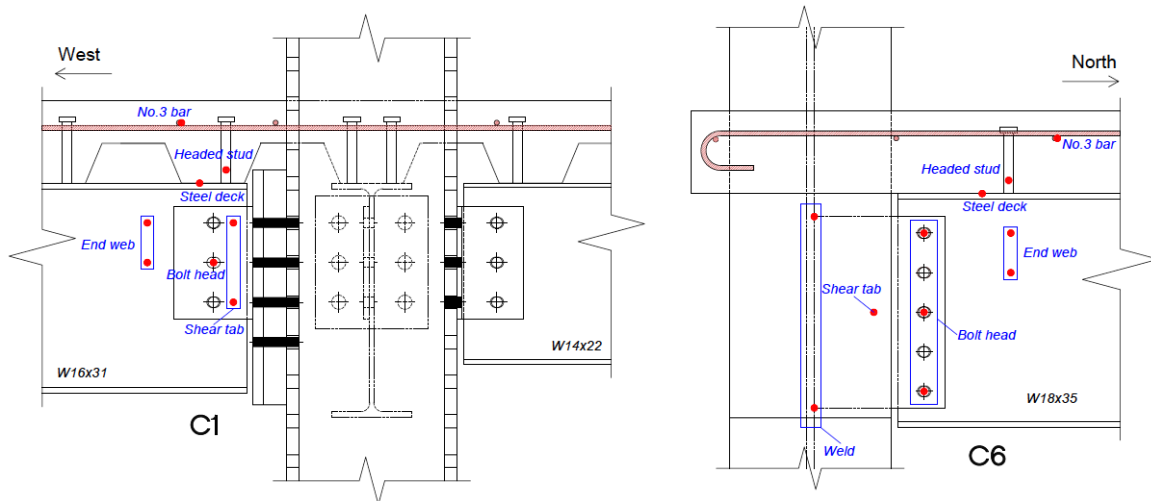
Fig. 24. Typical locations of temperature measurements in the beam-end (left) and girder-end (right) connection regions.

All beam-end connections within the fire test bay were protected with the same SFRM used for the connected beams and girders. Refer to Table 3 for the thickness of applied SFRM. Typical locations of the thermocouples mounted on the shear-tab connections of the floor beams are shown in Fig. 24. The average temperatures of the beam-end or girder-end connection regions are provided in Fig. 25 and Fig. 26. Temperatures of all ten connections exposed to fire are reported in Appendix A.7.

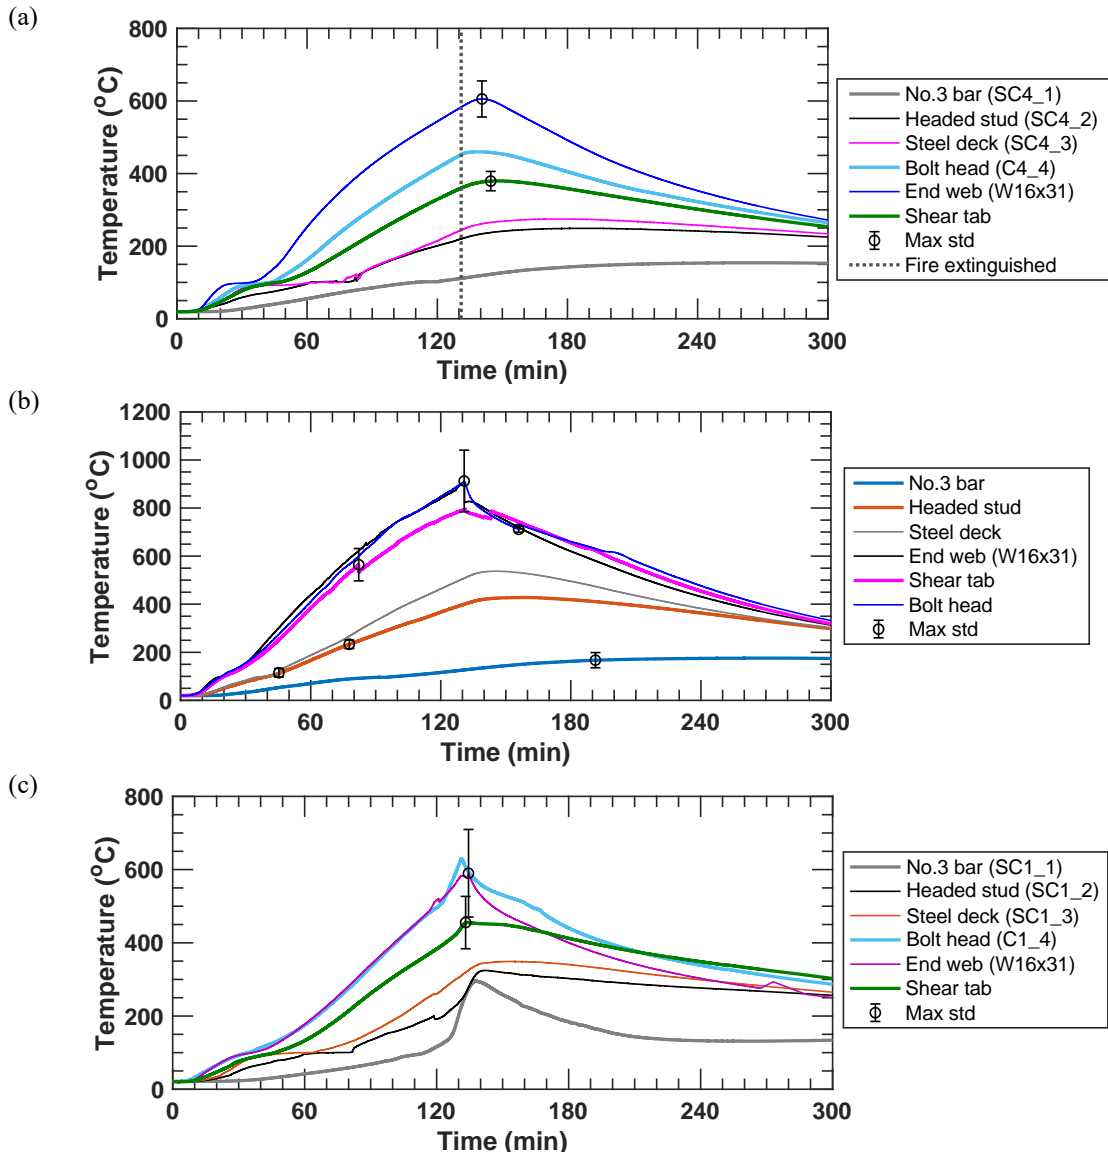
Fig. 25. Average temperatures of the beam-end connections of (a) north edge beam, (b) secondary beam, and (c) south edge beam with W16x31 shapes. Error bars indicate a maximum value of standard deviation of temperatures measured at multiple locations.

As shown in Fig. 25, the beam-to-girder connection region was heated more rapidly due to its proximity to the burners and a thinner layer of SFRM. The shear-tab connection temperature exceeded 800 °C on average during the fire exposure. Temperatures of the same connection at the north and south beam ends remained below 600 °C. The No.3 reinforcing bar over the connection remained below 200 °C for the north and secondary beams. However, the No. 3 bar temperature at the south beam ends sharply increased after 120 min, indicating concrete cracks.

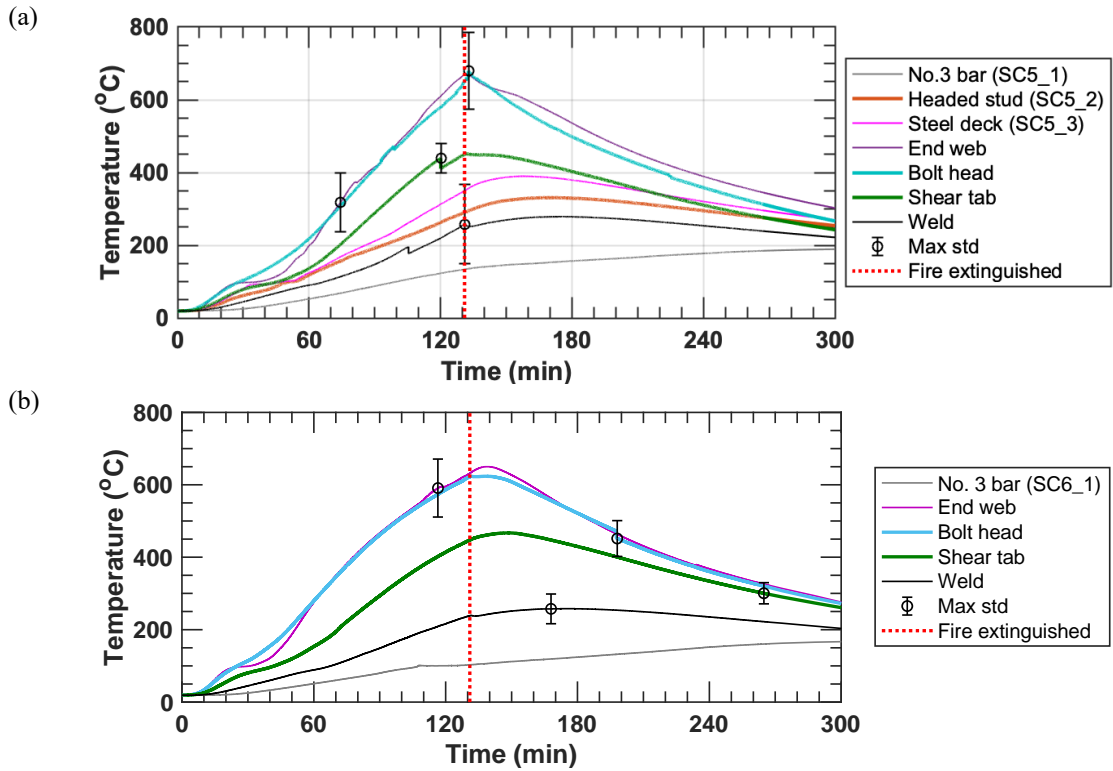
Fig. 26. Average temperature of (a) east girder end connection and (b) west girder end connection attached to W18x35 shapes. Error bars indicate a maximum value of standard deviation in temperatures measured at multiple locations.

The girder end-connection regions indicated a similar change in temperatures (Fig. 26). The beam end web and bolt head reached over 600 °C on average. However, temperatures of the extended shear tabs and welded joints were approximately 200 °C and 400 °C lower, respectively, because thermocouples in those regions were shaded by the column flanges. The No.3 bar temperature was considerably low with a peak value of 200 °C during cooling.

The temperature variation in the beam or girder end webs as well as bolt heads was as large as 25 %. This might be caused by local buckling of the end web leading to physical damages (fissures, debonding, or both) to applied SFRM where thermocouples were installed.

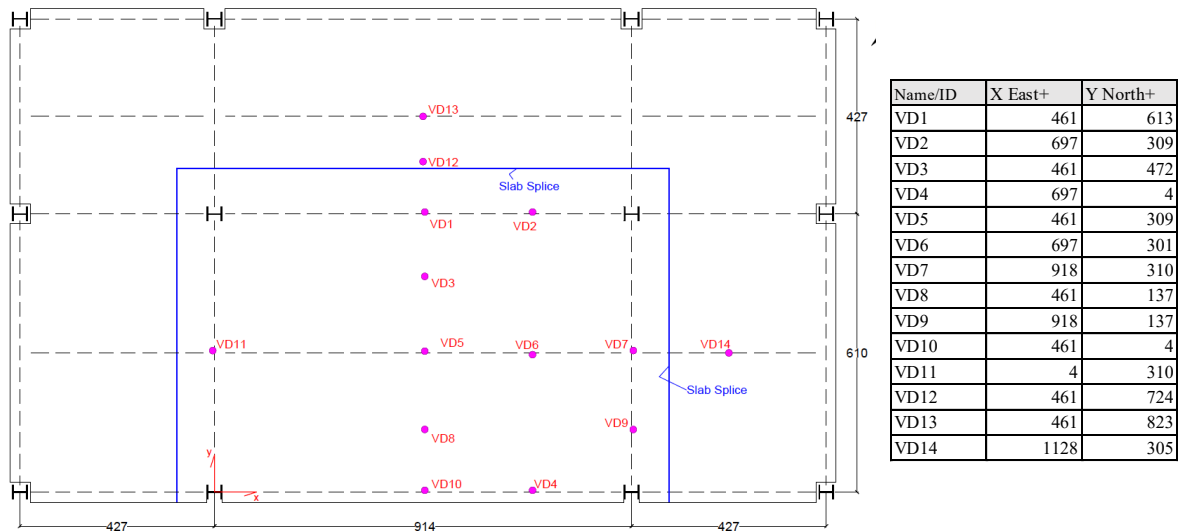
Fig. 27. Location of the vertical displacement (VD) measurements. Dimensions and coordinates are in cm.

A total of fourteen displacement transducers (named VD1 through VD14) were deployed to measure the vertical deflection of the test-bay and surrounding floors as shown in Fig. 27. Some vertical displacements are plotted with fire exposure time and the average bottom flange temperatures of the floor beams, as illustrated in Fig. 28. Other displacements not presented in this figure are reported in Appendix A.8. The positive values of displacements indicate the downward vertical displacements as the test floor assembly sagged under fire exposure. As mentioned earlier, the actuator loading was not removed until the 2-hr cooling phase was complete (i.e., 252 min in test time), whereas the test fire was extinguished at 131 min.

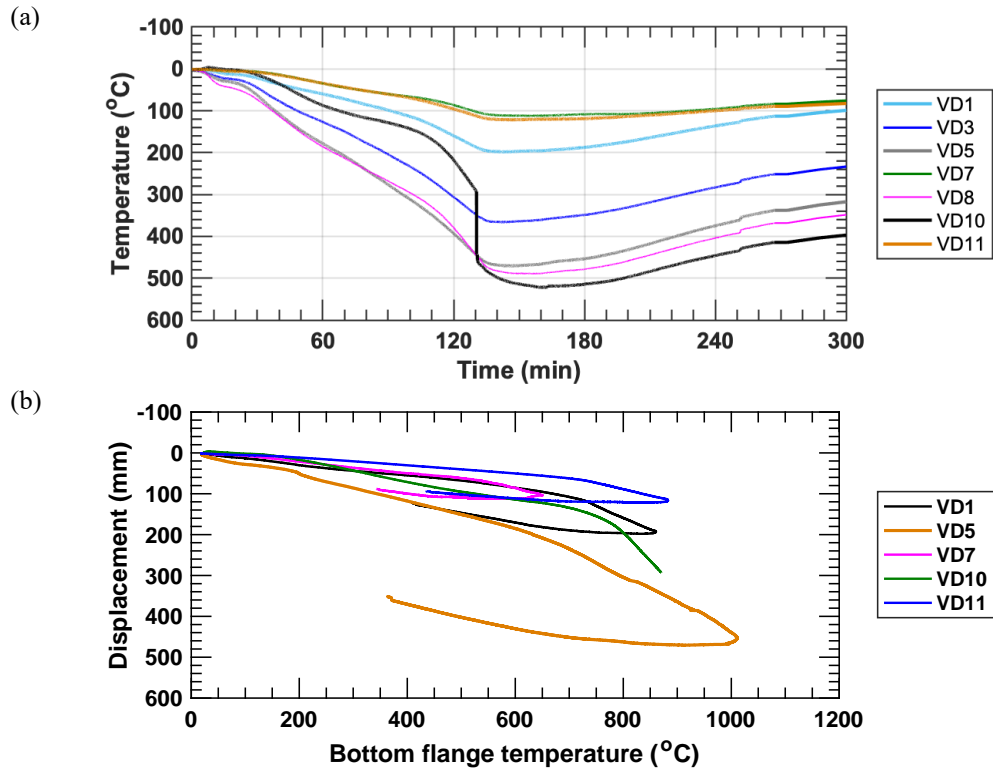
Fig. 28. Measured vertical displacements as a function of (a) fire exposure time and (b) bottom flange temperatures of the floor beams.

The mid-panel vertical displacement (VD5) increased at an approximate rate of $0.4 \text{ mm}/^\circ\text{C}$ until the bottom flange temperature of the secondary beam reached $700 \text{ }^\circ\text{C}$. The increase in the VD5 value became approximately $0.7 \text{ mm}/^\circ\text{C}$ afterward. The vertical displacement of the south (exterior) edge beam (VD10) increased more rapidly than other edge beams (VD1,

VD7 and VD11) because of their connectivity to the surrounding bays. A snapshot of the test video recording top of the test floor is shown in Fig. 29

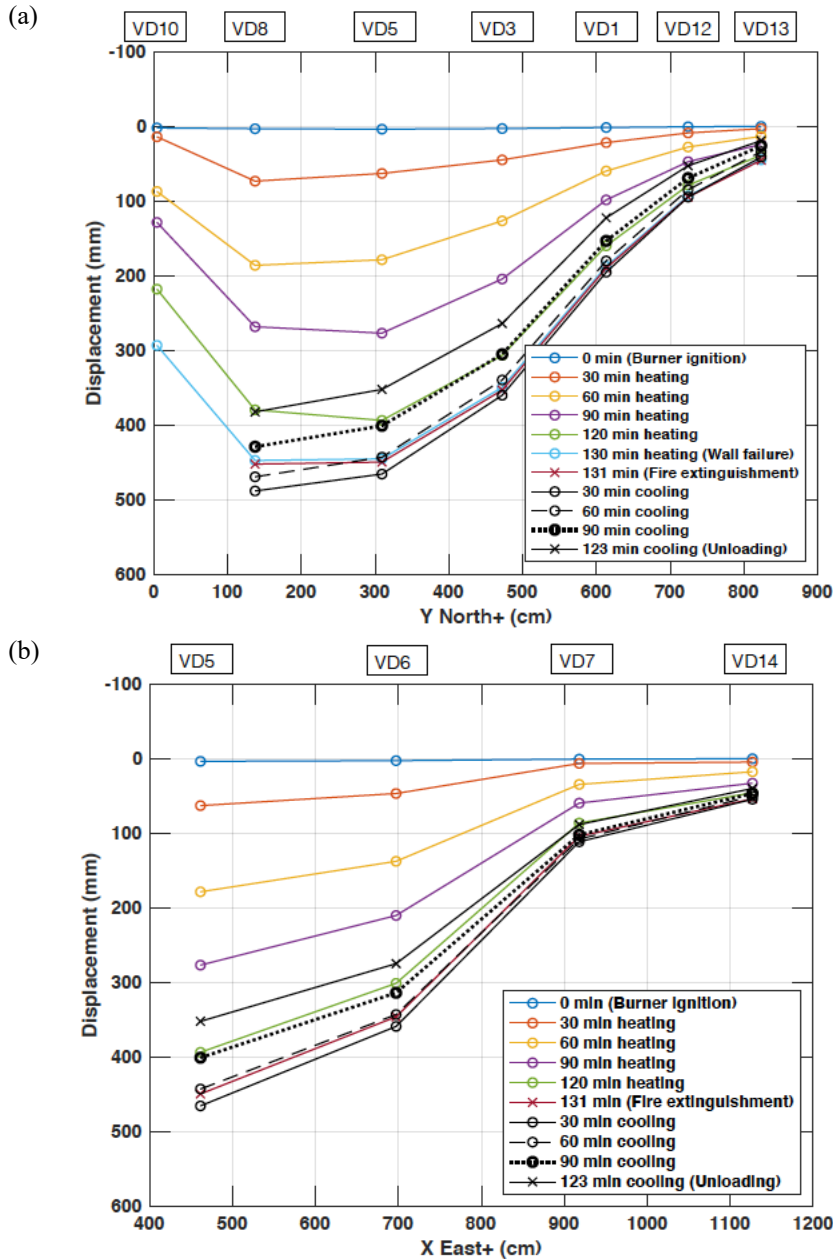
Fig. 30. Vertical displacement profile of the test floor assembly at (a) the north-south centerline and (b) the east-west centerline. The upper horizontal axes indicate the corresponding position of each vertical displacement sensors.

The temporal change in the vertical displacement measured along the centerlines of the test bay is illustrated in Fig. 30. The south half of the floor specimen deflected more than its north half since the No. 3 deformed bars placed perpendicular to the north edge beam provided some degree of rotational restraints, maintaining a good continuity with the steel reinforcement placed in the north surrounding bay which remained cool during fire loading.

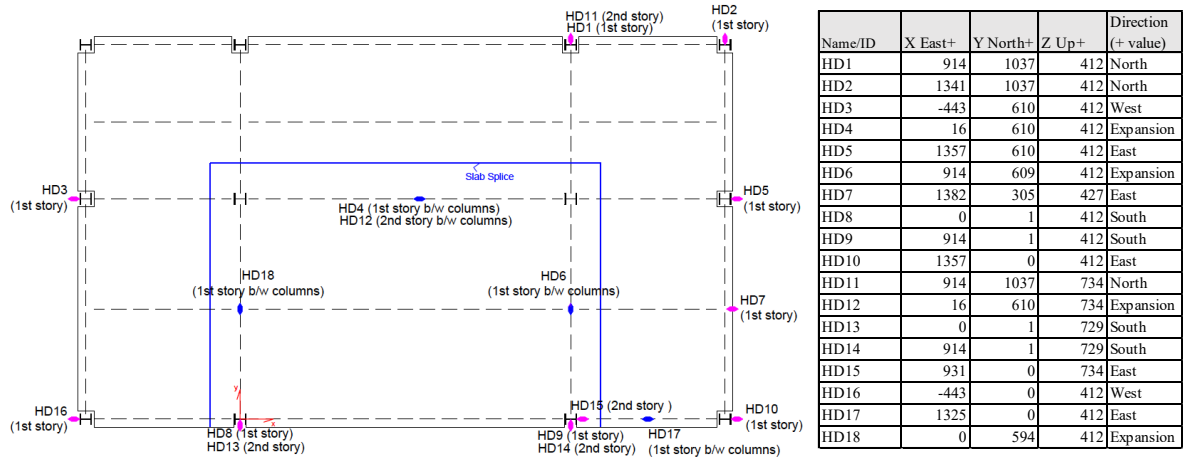
Fig. 31. Location of horizontal displacement (HD) measurements. The Z datum is defined at the laboratory strong floor. Coordinates are in cm.

A total of eighteen string potentiometers (HD1 through HD18) were deployed to measure the horizontal displacement of the test floor assembly and at the perimeter of the two-story prototype building; See Fig. 31. The HD4, HD6, HD18 sensors were used to measure thermal expansion of the north, east, and west edges of the fire test bay, respectively. The lateral displacements of the first-story columns (HD1 through HD3, HD5, HD8 through HD10, and HD16) as well as HD4 and HD6 were measured at 15 cm above the top surface of the test floor slab.

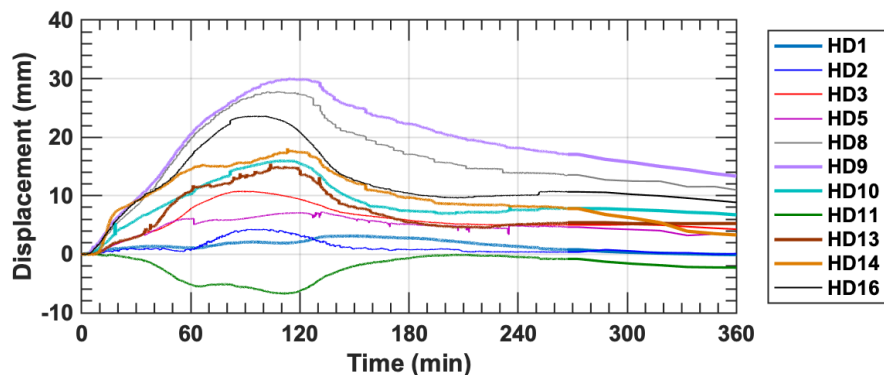
Fig. 32. Measured lateral displacements of the exterior columns.

Some horizontal (lateral) displacements of the exterior columns at the test floor level are illustrated in Fig. 32. Other displacements not presented in this figure are reported in Appendix A.8. As shown, approx. 5 min into fire loading, the displacements began to increase in the east or west direction due to thermal expansion of the test floor assembly. Simultaneously, the lateral displacement of the north column (HD11) at the second-story level increased toward south since this column was pulled together with the south columns deflecting toward the south during heating. The peak values of each displacement sensor occurred between 80 min and 120 min after the burner ignition. For instance, from 80 min to 95 min into heating, thermal expansion of the north edge beam (HD3) and the south edge beam (HD16) came to a halt, which suggests that local buckling could be initiated near the ends of these beams.

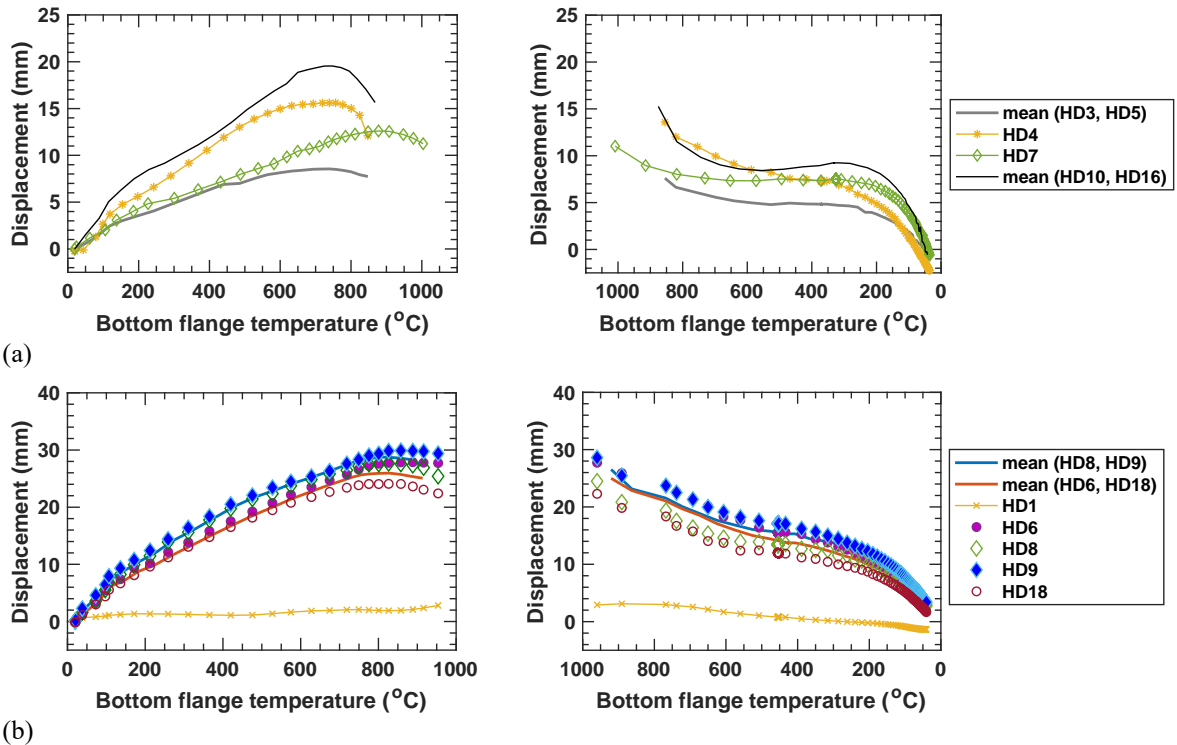
Fig. 33. Measured horizontal displacements as a function of bottom flange temperatures; (a) thermal elongation and contraction in the east-west direction and (b) thermal elongation and contraction in the north-south direction.

The horizontal displacements of the floor specimen are plotted as a function of the bottom flange temperatures of the fire-exposed steel beams or girders in the test bay; See Fig. 33. HD4 is plotted with the average bottom flange temperature of the north primary beam; HD7 is plotted with the average bottom flange temperature of the secondary beam; HD1, HD6, and HD9 are plotted with the average bottom flange temperature of the east girder; and HD8 is plotted with the average bottom flange temperature of the west girder.

Thermal elongation along the north edge of the test assembly (HD4) was approximately equal to two times the average displacement of the east and west exterior columns (HD3 and HD5), as shown in Fig. 33a. The change in the displacement values became less sensitive to the temperature beyond 600 °C. Thermal elongation along the longitudinal centerline (HD7) continued until the bottom flange temperature of the secondary beam reached to 870 °C, followed by a descending trend afterward. Thermal elongation along the south edge of the test assembly (HD10) continued until the bottom flange temperature of the south edge beam reached to 720 °C, followed by a descending trend afterward.

With the presence of the north surrounding bay, the east and west edges of the test assembly thermally elongated mostly toward the south. As shown in Fig. 33b, the average thermal elongation of the east and west edges (HD6 and HD18, respectively) were very similar to the average lateral displacement of the southeast and southwest column of the test bay (HD9 and HD8, respectively). Beyond 800 °C, those displacements stopped increasing and began to slowly decrease until the test fire was removed.

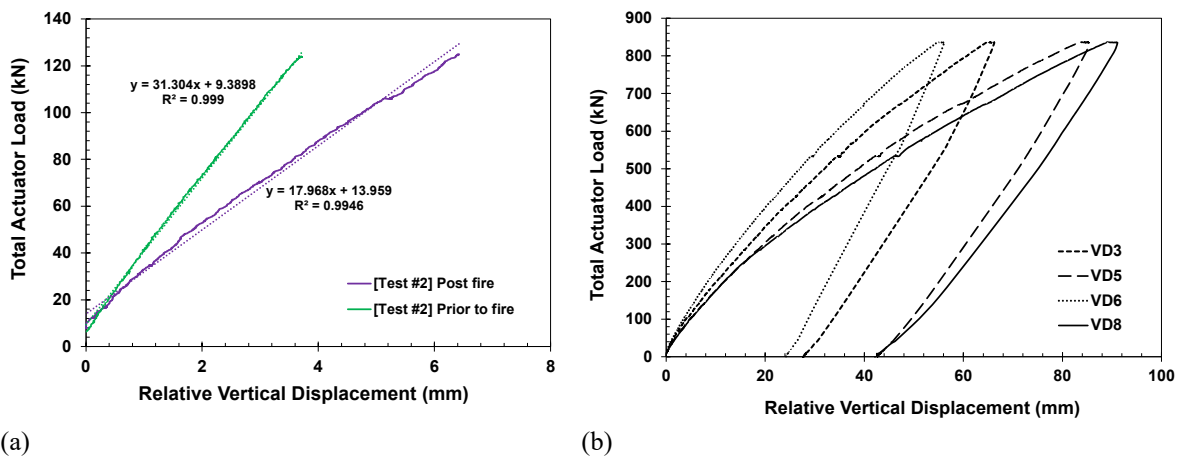
Fig. 34. (a) Initial bending stiffness and (b) load-displacement relationship during the post-fire loading test.

After cooldown, the test floor assembly was loaded again using the same hydraulic actuators used in the fire testing to examine its post-fire flexural behavior at ambient temperature. Locations of the loading points on the test floor remained unchanged (Refer to Fig. 4b). For this test, the mechanical loading was applied at an approximate rate of 9 kN/min until the hydraulic actuator system maxed out its load limit (836 kN). The bending stiffness of the test floor before and after the fire test is compared in Fig. 34a. As shown, the fire-damaged test floor retained approximately 42 % of its normal bending stiffness prior to fire exposure.

The total actuator load versus vertical displacement relationship is plotted in Fig. 34b. At a maximum load of 836 kN, the mid-span vertical displacement of the secondary beam (VD5) was about 85 mm, and the vertical displacement of the south middle slab (VD8) was about 91 mm, relative to the permanent displacement measured after cooldown from fire loading. The maximum gravity load was approximately 17.8 kPa (370 psf), which was estimated including self-weight of the test floor assembly prior to fire exposure and that of loading frames.

It is noteworthy that the test floor assembly still retained very large flexural strength (after cooldown) at least two times greater than the ASCE 7 load demand (9 kPa) for normal conditions determined from the load combination of 1.2 times dead load plus 1.6 times live load. A collapse mechanism was not developed even though the total floor load reached almost 90 % of the ambient-temperature moment capacity (21 kPa) of the as-designed secondary composite beam calculated in accordance with the AISC 360 specification [15] but with measured mechanical properties of steel and concrete at ambient temperature (Refer to Table 2 and Table 8, respectively).

Several factors might have influenced this high post-fire capacity of the test floor, including but not limited to (1) the rotational restraint provided by the steel reinforcement in the hogging moment region of the floor slab, (2) the negligible damage in headed stud anchors which developed the design composite action between the steel beams and concrete slabs under flexural loading, and (3) the concrete surrounding the headed studs appeared to be less affected by thermal degradation as temperatures were measured lower than 200 °C in those locations.

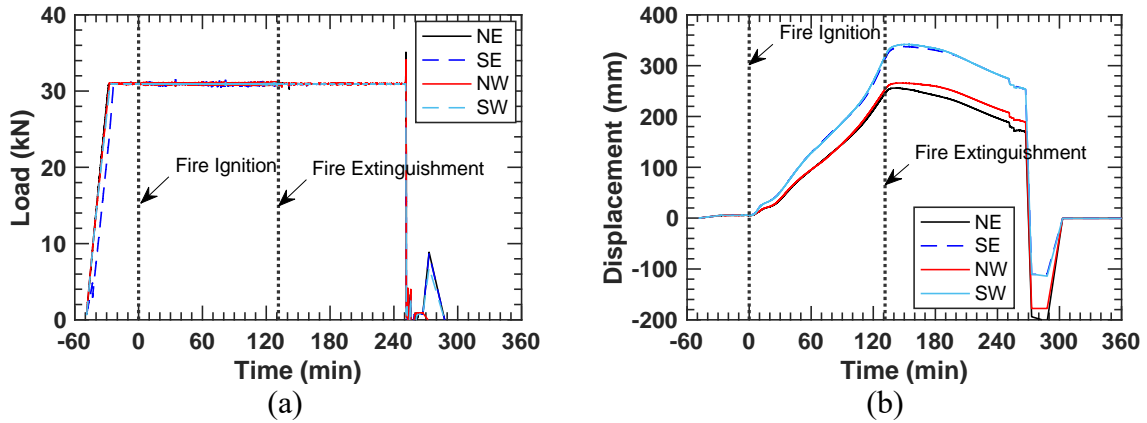
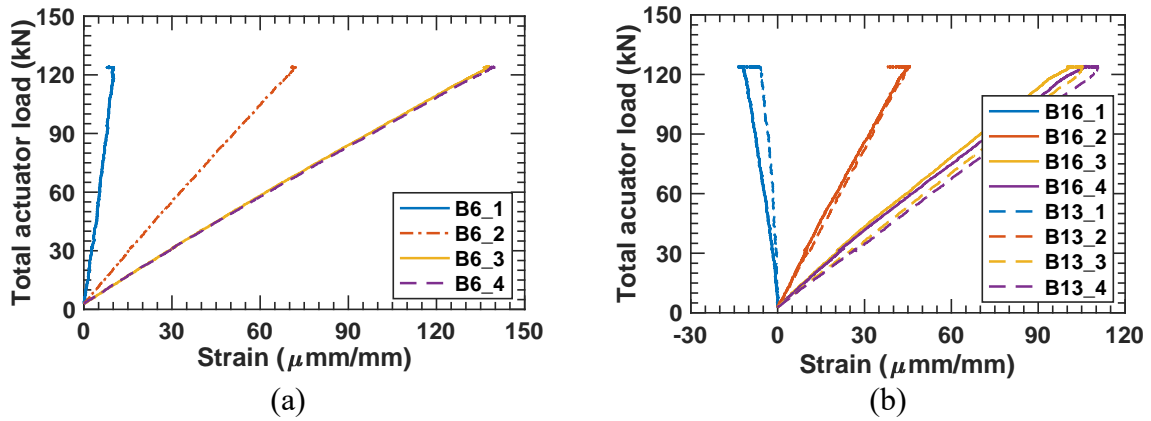
Four servo-hydraulic actuators (each named as NW, NE, SW, and SE) were used to apply mechanical loads that were uniformly distributed at twenty-four points across the test floor slab. Those actuators were mounted at the NFRL basement below the fire test bay (Fig. 39). Each actuator provided mechanical loading on the test floor at six points spaced 152 cm apart (Fig. 40a). The beam strains were measured using strain gauges during mechanical loading at ambient temperatures only (Fig. 40b). Measured actuator loads, actuator displacements, and the beam strain values are provided in Fig. 41 and Fig. 42.

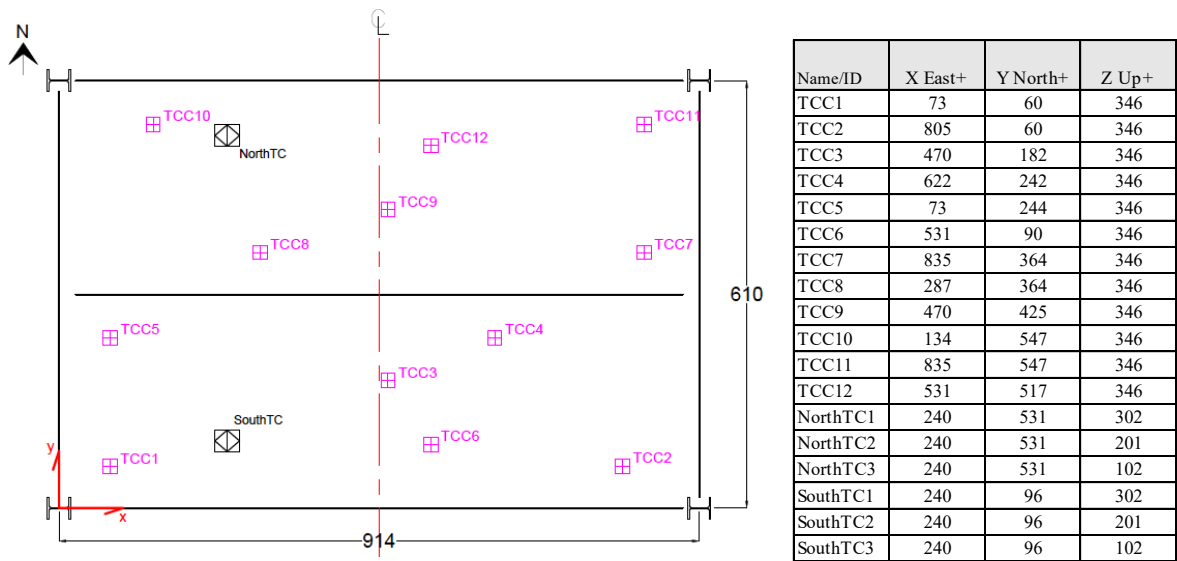
Fig. 43. Locations of thermocouple probes used for gas temperature measurements within the fire test bay. The Z datum of NorthTC and SouthTC probes is at top surface of the compartment floor. Dimensions and coordinates are in cm.

OMEGACLAD sheathed thermocouples (model: TJ36-CAXL-14U-24) [31] were used to measure the gas temperatures inside the test compartment. Twelve thermocouple probes (TCC1 through TCC12) were mounted 30.5 cm ($z = 346$ cm) below the floor specimen soffit (i.e., the compartment ceiling) for gas temperature measurements. Two thermocouple trees were placed inside the test compartment, including the north tree 79 cm from the north wall (NorthTC) and the south tree 96 cm from the south wall (SouthTC). Thermocouple probes were located approx. 10 cm away from the exposed surface of Kaowool blanket wrapping the mounting stand. Photographs of some installed thermocouple probes are shown in Fig. 44.

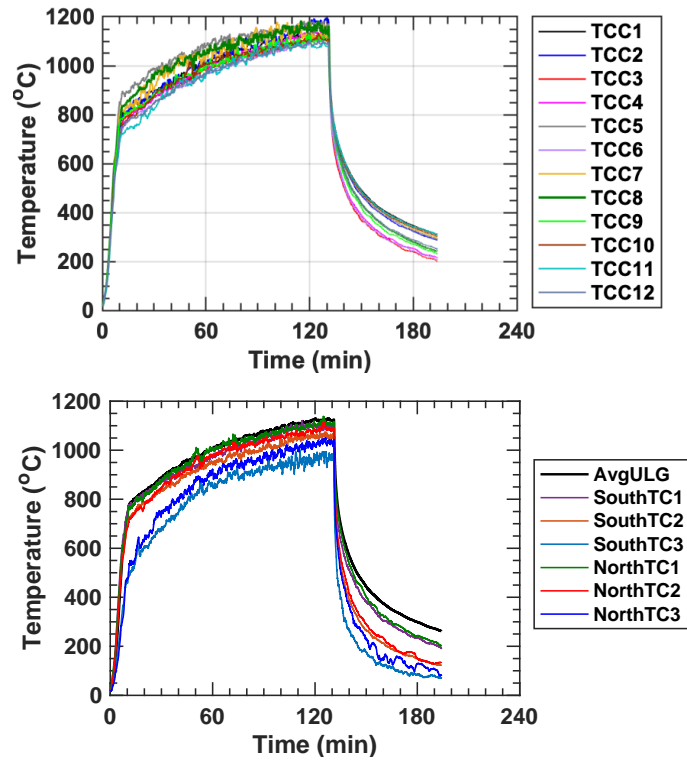
Fig. 45. Gas temperatures inside the test compartment. Fire was extinguished at 131 min.

The hottest spot was measured at TCC5 which was approximately 50 °C above the average upper layer gas temperature. TCC11 indicated the lowest temperature, about 50 °C below the average value. During cooling, temperatures of TCC6 decreased much quicker than TCC11.

In addition, during the first 15 min of heating, the gas temperatures measured at the north and south trees differed by a maximum of 100 °C, due to air intake through the south ventilation opening. However, this temperature variability also became smaller as the test fire continued longer than an hour.

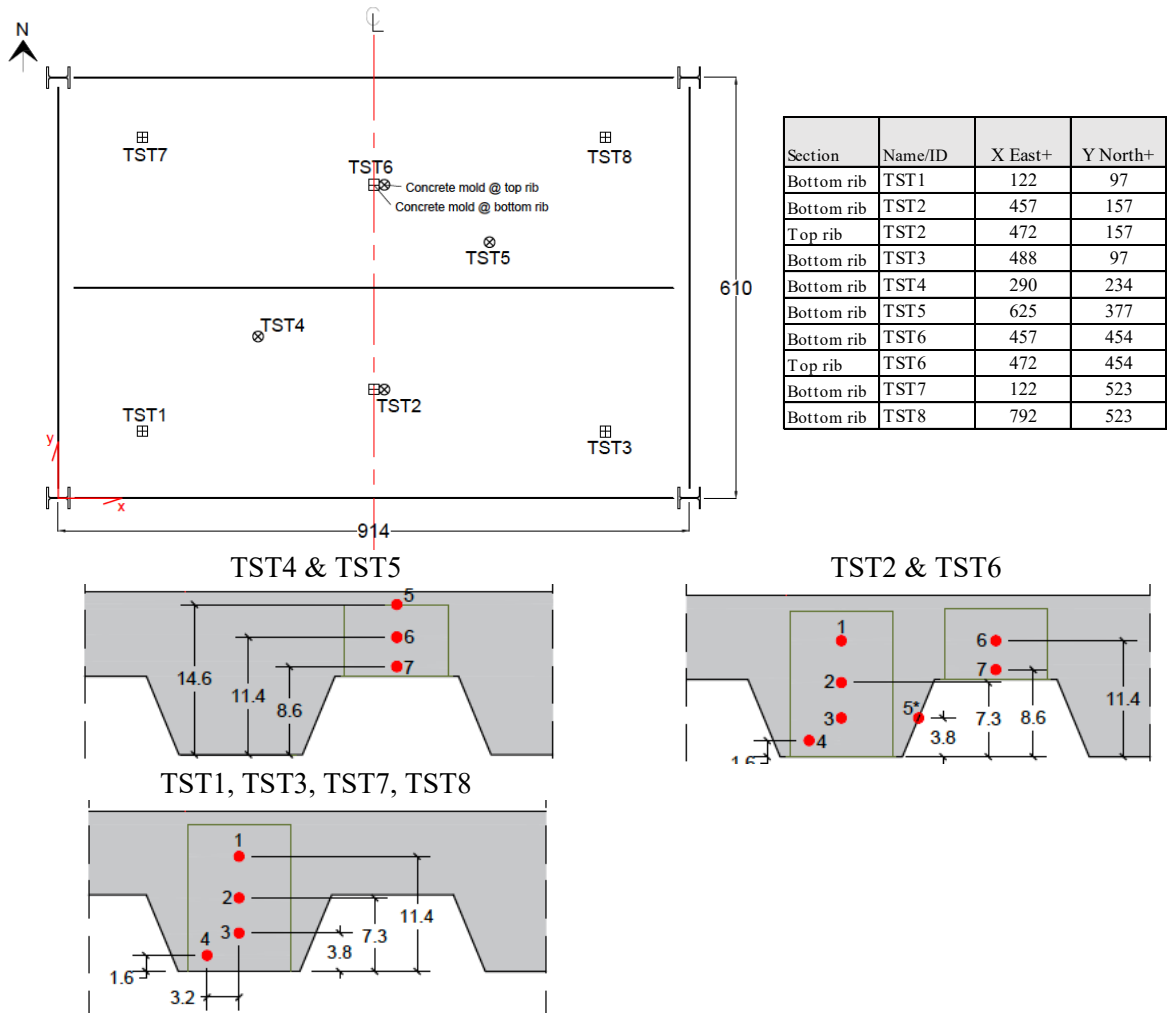
Fig. 46. Locations of thermocouples installed within the test floor slab. Dimensions and coordinates are in cm.

Glass sheathed thermocouples (model: GG-K-24) [32] were used to measure concrete temperatures. A total of ten thermocouple trees, made of the 10 cm diameter concrete cylinders, were placed in the test floor slab. Locations of these cylinders (TST1 through TST8) are shown in Fig. 46. In each cylinder, two to four thermocouples were secured through the thickness of the slab, except for TSTi_5* which was mounted 3 mm above the deck pan.

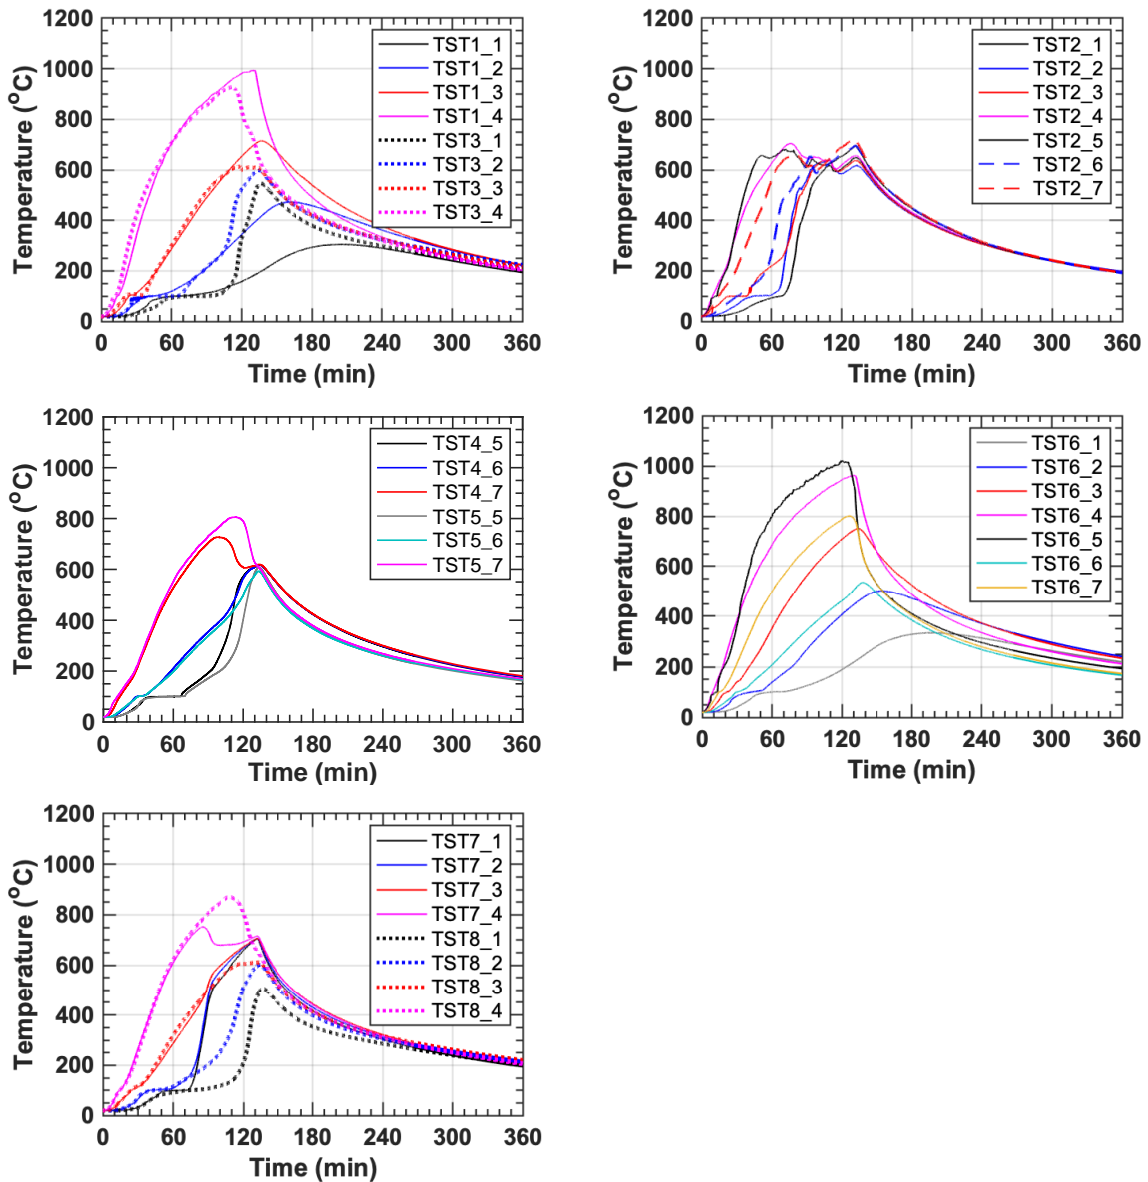
Fig. 47. Concrete temperatures through the depth of the test floor slab. Fire was extinguished at 131 min.

Table 12 shows the list of thermocouple probes used to estimate the average temperatures at specific depths which are plotted in Fig. 20. For this estimation, locations 1 and 2 only included TST1 and TST6 thermocouples only because thermocouples at other TST locations appeared to be significantly affected by concrete damage. With the same reason, locations 6 and 7 only included TST 4 through TST6 thermocouples. All raw data are plotted in Fig. 47, where some temperature readings (e.g., TST2_1, TST2_2, TST3_1, and TST3_2) started increasing rapidly after 60 min to 70 min into heating.
