Fire Resilience in Steel-Concrete Structures Part II: Advanced Solutions

Course No: S03-033
Credit: 3 PDH

This course was adapted from the NIST U.S. Department of Commerce, Publication No. NIST TN 2203, “Fire Resilience of a Steel-Concrete Composite Floor System: Full-Scale Experimental Evaluation for Influence of Slab Reinforcement (Test #2)”, which is in the public domain.

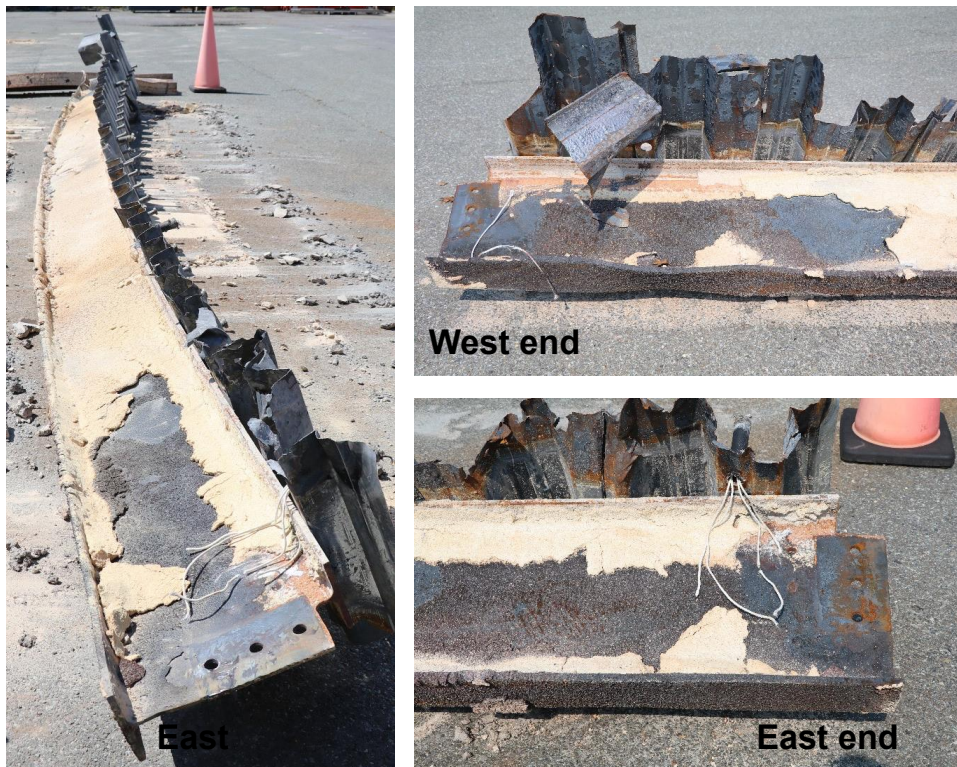
Fig. 72. Post-test photographs: Secondary beam.

Post-test photographs of the support beams and girders are shown in Fig. 72 through Fig. 75. It is noteworthy that the west girder exhibited a local rupture of the bottom web toe at the north end because of web local buckling (Fig. 76).

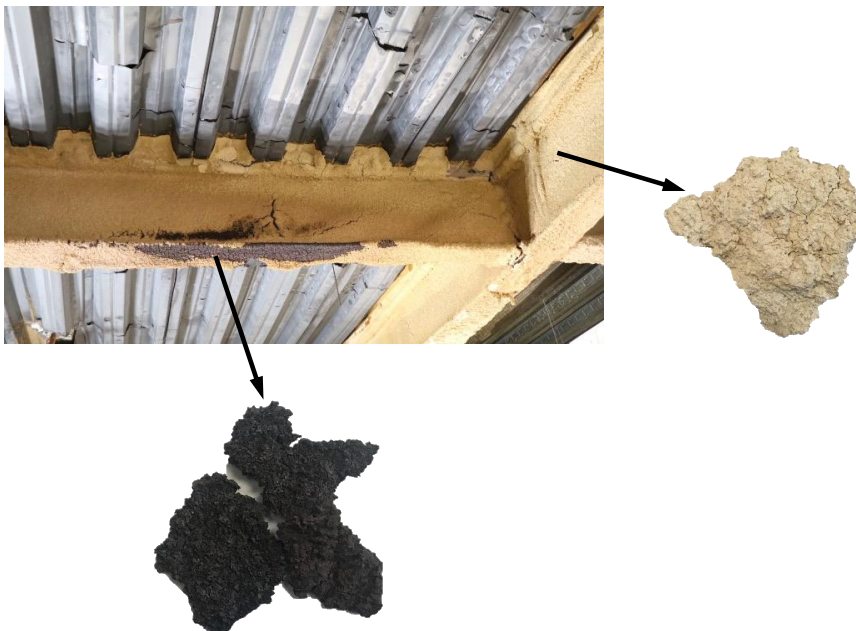
After the fire testing, there were two spots toward the ends of the secondary beam where the fire exposed SFRM turned black and charcoal color as shown in Fig. 77. Those locations were directly above the east and west burners. A handheld XRF (X-ray fluorescence) analyzer manufactured by Olympus [37] was utilized to measure chemical compositions of the samples collected from the secondary beam at two different locations (the west end and midspan) after cooling. A comparison of some scanned results is shown in Fig. 78, along with the unused SFRM powder. Although a further study is needed, this SFRM discoloration was likely caused by high-temperature oxidation or phase change of the steel heated beyond 1000 °C. Refer to TB5 and TB7 temperatures in Sect. A.6. The charcoal-colored sample contained about 51 % iron by mass, whereas the unused sample or other exposed sample contained about 2 %.

Fig. 77. Samples of fire exposed SFRM applied on the support steel beam framing.
