Effects of Weathering on the Properties of Vinyl Siding

Course No: T02-010
Credit: 2 PDH

This course was adapted from the NIST U.S. Department of Commerce, Publication No. NIST TN 2304, “Effects of Weathering and Formulation on the Properties of Vinyl Siding”, which is in the public domain.

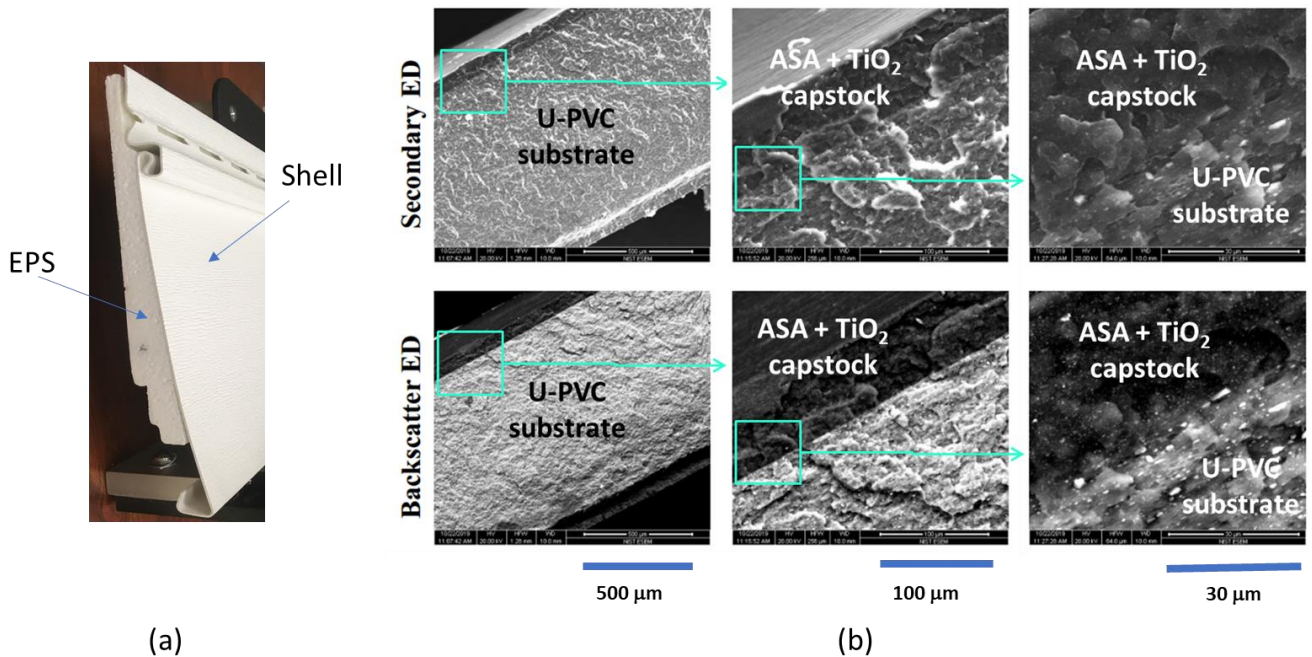
Fig. 2. Images showing: (a) photo of the commercial vinyl siding and (b) SEM images of the front shell at different scales with both secondary electrons (upper row) and backscattered emission (bottom row).

The insulated vinyl siding featured a nominally 1.1 mm-thick vinyl shell and EPS insulation (Fig. 2a). The shell consisted of an approximately 40 μm - thick ASA capstock with high concentration of TiO_2 and a U-PVC substrate (Fig. 2b).

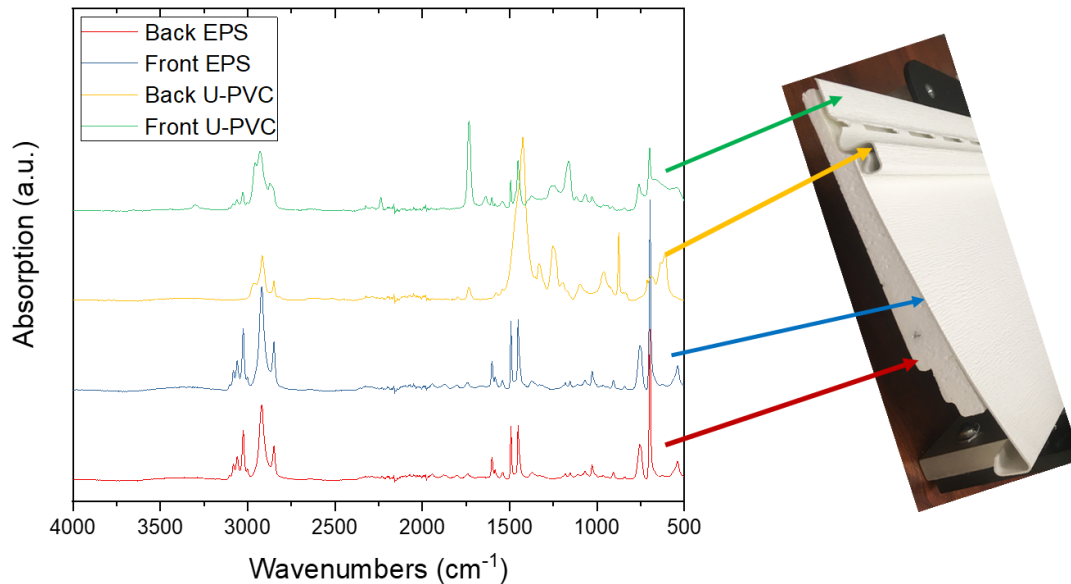
Fig. 3. FTIR spectra of the component of the vinyl siding.

Fig. 3 shows the FTIR spectra for all the components of the insulated vinyl siding: the vinyl shell, which includes the ASA capstock with TiO_2 (hereafter, **front U-PVC**), U-PVC side in contact with EPS (**back U-PVC**), EPS surface in contact with U-PVC (**front EPS**), and EPS surface on the vinyl siding backside (**back EPS**). The characteristic FTIR peaks for U-PVC (Table 3), ASA compounds (Table 4), and EPS (Table 5) are shown by front U-PVC, back U-PVC, and front/back EPS, respectively.

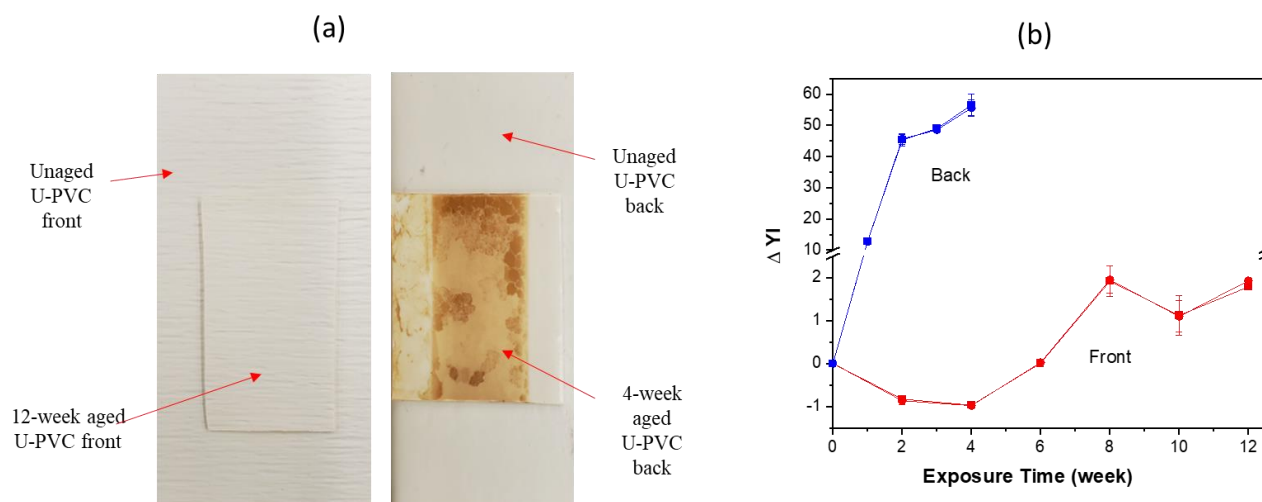
Fig. 7. (a) Photos of U-PVC surfaces (front and back) before and after QUV aging; (b) corresponding yellowness index (ΔYI) as a function of exposure duration in QUV. Data points indicate the mean, and the error bars the standard deviation (5 replicates).

The role of the capstock (TiO₂-rich ASA layer) as a weathering protection layer can be demonstrated in the QUV weathering tests, as shown in Fig. 7. There were no significant color changes on the front U-PVC after aging for up to 12 weeks. However, after about four weeks, the back U-PVC side turned yellow/brown.

Fig. 7b displays the corresponding changes in the yellowness index (ΔYI) as a function of exposure weeks in QUV chambers for the front and back surfaces. The values of ΔYI of the back U-PVC at four weeks are much higher than the front (no color change). A significant increase in ΔYI for the front U-PVC face was first observed in week 6.

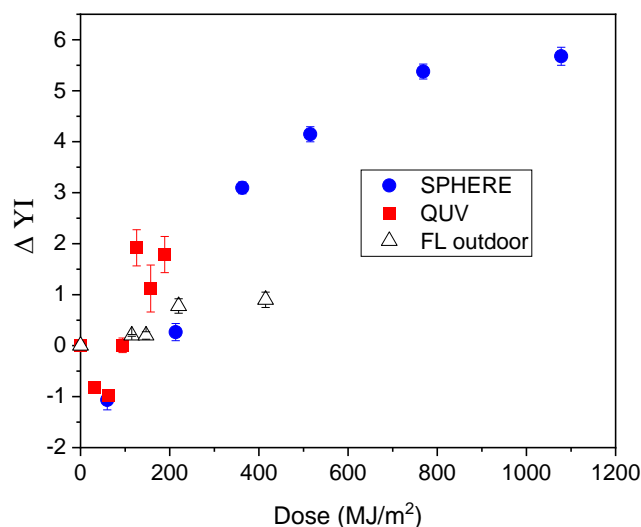
Fig. 8. Changes in yellowness index (ΔYI) as a function of exposure dose for SPHERE QUV and FL outdoor exposure conditions. Data points indicate the mean and the error bars, the standard deviation values (5 replicates).

Fig. 8 compares the yellowness index (YI) measured on the front U-PVC during weathering in QUV and SPHERE. ΔYI values in QUV are higher than ΔYI in SPHERE. Thus, QUV weathering appears more severe than the SPHERE weathering at a given dose exposure. The primary causes could be water condensation and humidity on the sample surface. Although OH radical production on the TiO₂ surface remains relevant (see section 1.3), the primary impact lies in autocatalytic degradation facilitated by hydrochloric acid [48]. The FL outdoor exposed samples (64 weeks, dose up to 415 MJ/m²) showed relatively low color change and some dirt accumulated on the surfaces. This result is mainly attributed to temperature. The average exposure temperature was 27 °C in FL outdoors, 55 °C in SPHERE, and 60 °C in QUV (Table 2). Other factors, such as rain (washing off the photodegradation products), could also affect ΔYI in FL outdoors.

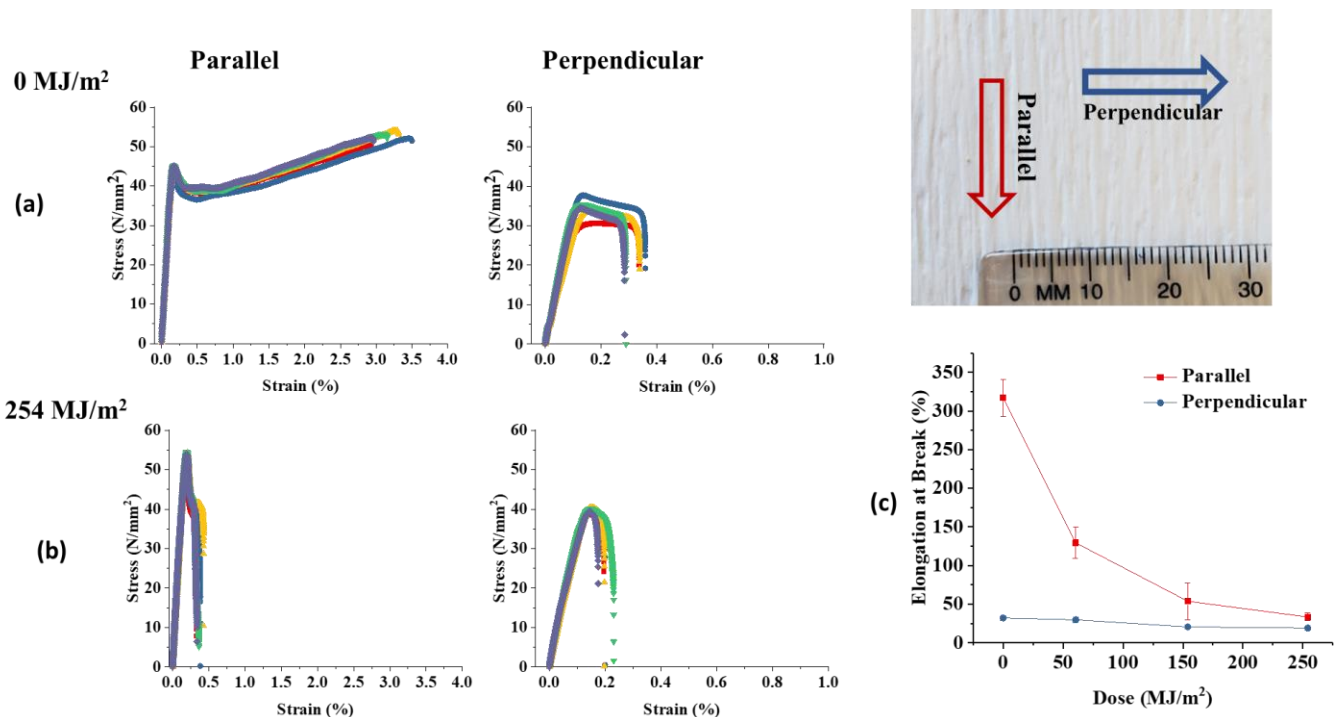
Fig. 13. Tensile tests for dogbones cut parallel and perpendicular to the vinyl siding pattern direction: (a) stress-strain curves before weathering; (b) stress-strain curves after weathering (254 MJ/m^2); (c) elongation at break vs. dose. Data points indicate the mean and the error bars the standard deviation calculated over 5 replicates.

The tensile properties were affected by the orientation (either parallel or perpendicular) of the dogbone (DB) specimen *versus* the surface pattern (Fig. 13). For perpendicular-cut DBs, the elongation at break (EaB) varies from $(0.32 \pm 0.03) \%$ before weathering to $(0.2 \pm 0.02) \%$ after UV exposure (254 MJ/m^2). The EaB values (Fig. 13c) are slightly affected by UV dose. For parallel-cut DBs, the elongation at break (EaB) varies from $(3.11 \pm 0.3) \%$ before weathering to $(0.36 \pm 0.06) \%$ after UV exposure, and the EaB values change from over 300 % at 0 MJ/m^2 to 40 % at 254 MJ/m^2 . Because parallel-cut DBs are more sensitive than perpendicular-cut DBs to weathering effects, parallel-cut DBs were used for the remainder of this study.

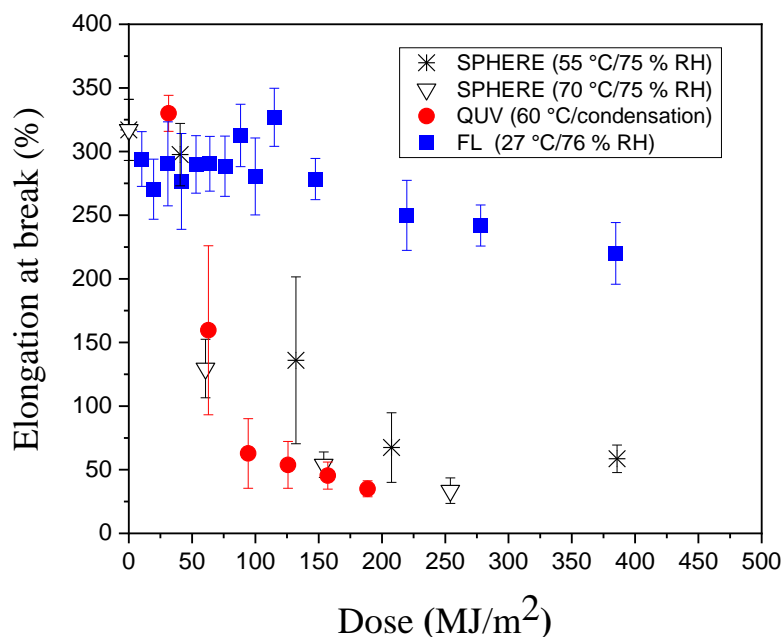
Fig. 14. Elongation at break (EaB) of U-PVC under QUV exposure at four exposure conditions as indicated. The EaB values are average of 5 measurements and error bars represent one standard deviation.

The weathering conditions have a substantial impact on the mechanical properties, as shown in Fig. 14. The degradation rate of EaB: $\text{EaB (FL)} \ll \text{EaB (SPHERE } 55 \text{ }^\circ\text{C, } 75 \text{ \% RH)} < \text{EaB (SPHERE } 70 \text{ }^\circ\text{C, } 75 \text{ \% RH)} \cong \text{EaB (QUV)}$. The results of the QUV test at $60 \text{ }^\circ\text{C}$ with water condensation on the sample surface were similar to those at SPHERE $70 \text{ }^\circ\text{C, } 75 \text{ \% RH}$ conditions and provided much more damage than those at SPHERE $55 \text{ }^\circ\text{C, } 75 \text{ \% RH}$. The effect of weathering conditions

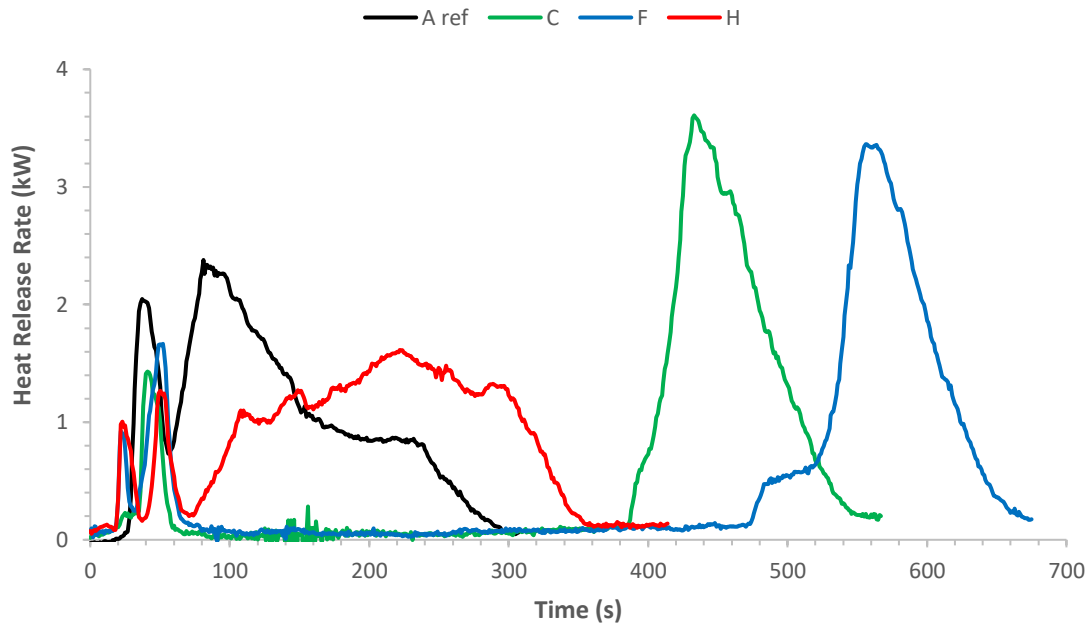
Fig. 22: Heat release curves measured for assemblies of U-PVC and XPS sheets according to ASTM E3367.

Understanding vinyl siding's ability to prevent flame penetration into an adjacent flammable insulation layer is of extreme interest for fire building safety, especially in areas subject to WUI fires. Furthermore, with the adoption of IECC 2021, exterior insulation will be required in U.S. climate zones (4 and above), where vinyl siding is often the most common siding material in residential buildings. To assess the barrier performance of the U-PVC formulations investigated in this study, a U-PVC sheet was placed on top of a 25 mm thick XPS foam insulation and tested according to ASTM E3367. The bottom of the assembly was open (see Fig. 1c) so that burn-through could be easily detected and the fire barrier performance among U-PVC formulations could be easily compared. The higher the barrier performance of U-PVC, the longer the burn-through time, as revealed by the ignition of the XPS foam.

The fire barrier performance of U-PVC was investigated following protocols defined in ASTM E3367. All the U-PVC formulations investigated failed to protect the polystyrene foam substrate. The failure mechanism was identical in all formulations. It involved charring, shrinking, melting, and tearing on the surface of U-PVC, allowing flame penetration into the foam substrate. These results show that U-PVC is a remarkable inherently flame-retardant polymer but does not serve as an effective fire barrier. Further research is required to develop modified U-PVC formulations and building hardening solutions that may enable the use of vinyl siding in high-fire risk areas.
